Fire Department Facility Study by CNH Architects

Fire Department Facilities Study

October 12, 2023

CNH Architects

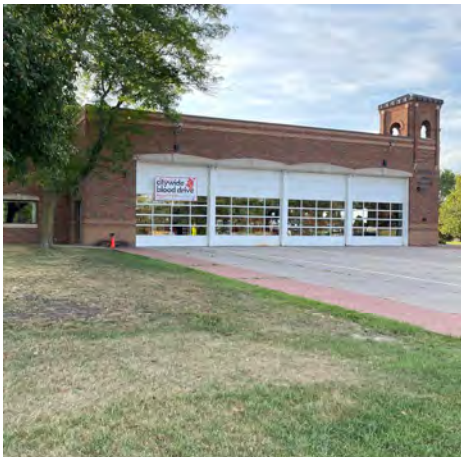
Infrastructure

The existing site layout does provide adequate circulation and traffic flow. There is a drive that extends from this site directly north to the Heritage Center that does not need to be maintained. The site does have room for building and parking expansion. There is not separate public and firefighter parking. The current public parking is accessed from the same drives used for apparatus returning to the station which is not ideal.

The apparatus return off of Holyoke Avenue and 202nd Street West/County Road 50. The apparatus respond onto Holyoke Avenue towards the west. There is a roundabout at the intersection of Holyoke Avenue and 202nd Street West/County Road 50 on the southwest corner of the site. When apparatus have their lights and sirens on, vehicles tend to stop in the roundabout affecting response time. There is a fire truck warning sign north of the station for vehicles heading south on Holyoke Avenue.

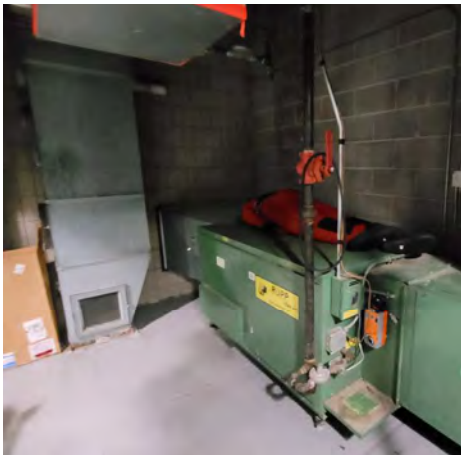
Maintenance

The mechanical and electrical systems have reached the end of their life cycle and need to be replaced. The generator does not provide full building coverage, so a new generator with full building coverage is required.

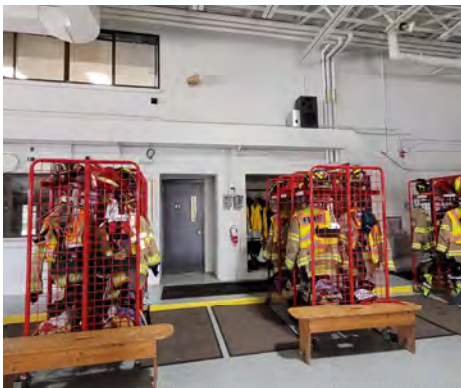
Health & Safety

The existing station raises several health and safety concerns for the firefighters that utilize the station. There is currently cross contamination between spaces and items that contain carcinogens that are directly affecting the health of firefighters. The turnout gear is currently stored in the apparatus bays where the apparatus expels carcinogens directly onto cleaned turnout gear. There is no tailpipe exhaust removal system in the apparatus bays. There is no true separate decontamination area for firefighters to decontaminate or clean gear and equipment. There is a curb between the station area and apparatus bays which is a trip hazard.

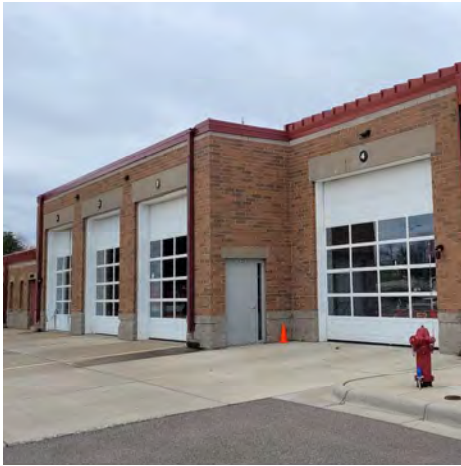
Infrastructure

The existing site layout does not provide adequate circulation and traffic flow. The site does have some room for building and parking expansion, but the drive locations are limited due to the location of the roundabout. The current public parking is accessed from the same drives used for apparatus returning to the station which is not ideal.

The apparatus return off of Dodd Boulevard and Flagstaff Avenue. The apparatus respond onto Flagstaff Avenue towards the west. There is a roundabout at the intersection of Dodd Boulevard and Flagstaff Avenue at the northwest corner of the site. When apparatus have their lights and sirens on, vehicles tend to stop in the roundabout affecting response time. There are fire truck warning signs in both directions on Dodd Boulevard and Flagstaff Avenue.

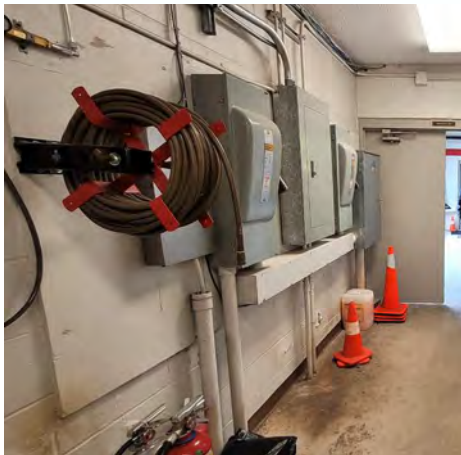
Maintenance

The mechanical systems consist of a furnace only and no rooftop units. The mechanical and electrical systems have reached the end of their life cycle and need to be replaced. The generator does not provide full building coverage, so a new generator with full building coverage is required.

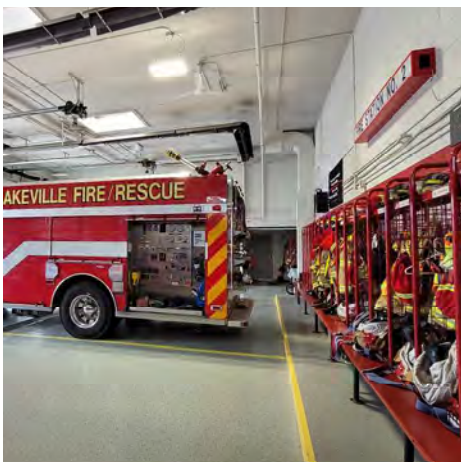
Health & Safety

The existing station raises several health and safety concerns for the firefighters that utilize the station. There is currently cross contamination between spaces and items that contain carcinogens that are directly affecting the health of firefighters. The turnout gear is currently stored in the apparatus bays where the apparatus expels carcinogens directly onto cleaned turnout gear. There is no tailpipe exhaust removal system in the apparatus bays. There is no true separate decontamination area for firefighters to decontaminate or clean gear and equipment and there is no shower in the station for decontamination. There is a curb between the station area and apparatus bays which is a trip hazard.

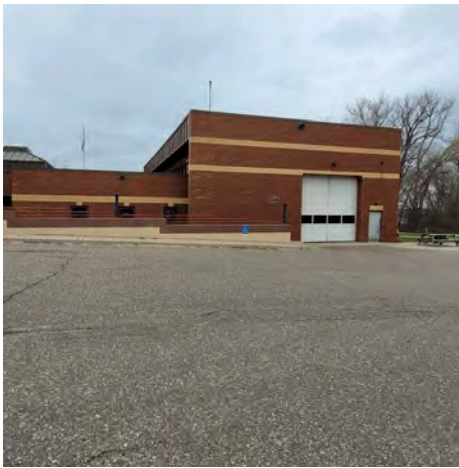
Infrastructure

The existing site layout does provide adequate circulation and traffic flow. The site does have room for building and parking expansion, but the existing communications building restricts where the expansions can be. The drive locations are limited due to the location of the roundabout and the pond just south of the site. The current public parking is accessed from the same drives used for apparatus returning to the station which is not ideal. Apparatus are unable to move between the west and east sides of the site without exiting onto Kenrick Avenue to re-enter the site via a separate drive.

The apparatus return and respond off of Kenrick Avenue towards the west. There is a roundabout at the intersection of Kenrick Avenue and 175th Street West at the southwest corner of the site. When apparatus have their lights and sirens on, vehicles tend to stop in the roundabout affecting response time. There are fire truck warning signs with lights in both directions on Kenrick Avenue and one heading east on 175th Street West.

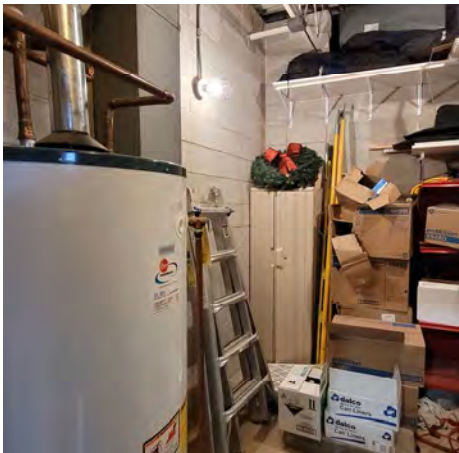
Maintenance

The mechanical and electrical systems have reached the end of their life cycle and need to be replaced. The generator does not provide full building coverage, so a new generator with full building coverage is required.

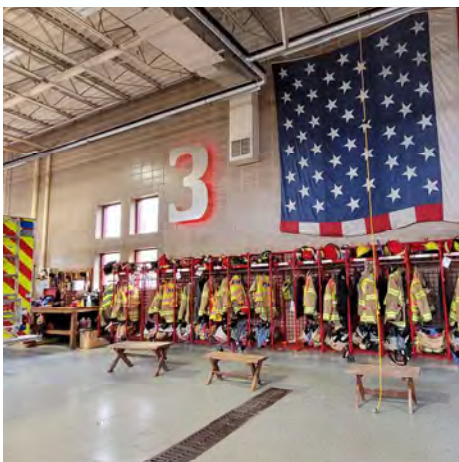
Health & Safety

The existing station raises several health and safety concerns for the firefighters that utilize the station. There is currently cross contamination between spaces and items that contain carcinogens that are directly affecting the health of firefighters. The turnout gear is currently stored in the apparatus bays where the apparatus expels carcinogens directly onto cleaned turnout gear. There is no tailpipe exhaust removal system in the apparatus bays. There is no true separate decontamination area for firefighters to decontaminate or clean gear and equipment. There is a curb between the station area and apparatus bays which is a trip hazard.

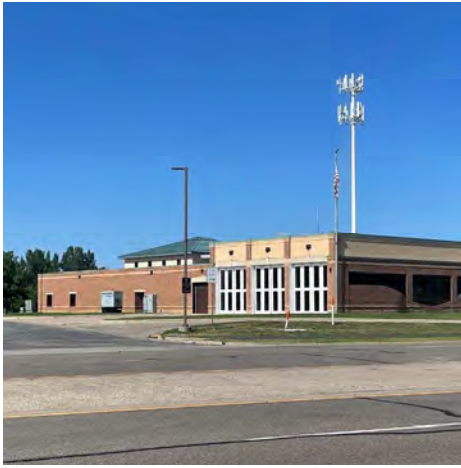
Infrastructure

The existing site layout does provide adequate circulation and traffic flow. The site does have room for building and parking expansion. There is not separate public and firefighter parking and the current public parking is accessed from the same drives used for apparatus returning to the station which is not ideal.

The apparatus return and respond off of the drive to the west of the station. When responding, the apparatus head south on the drive to 185th Street West where there is surmountable curb for the divided four lane road to respond east or west. There are fire truck warning signs in both directions on 185th Street West.

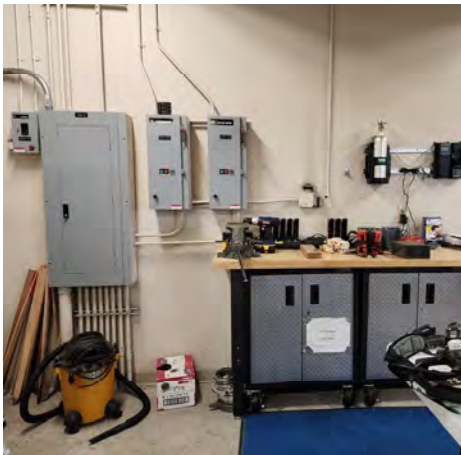
Maintenance

The mechanical and electrical systems have reached the end of their life cycle and need to be replaced. The generator does not provide full building coverage, but is more than likely not sized appropriately to cover additional loading that would occur with expanding the building size and would need to be replaced.

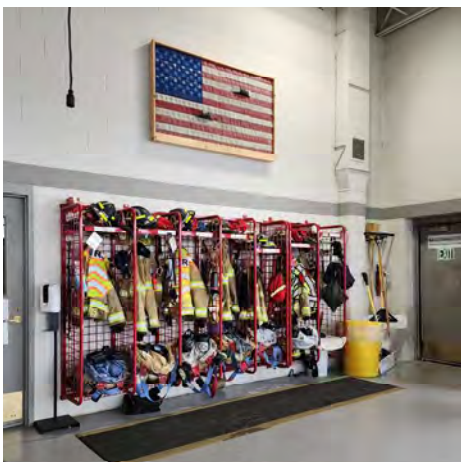
Health & Safety

The existing station raises several health and safety concerns for the firefighters that utilize the station. There is currently cross contamination between spaces and items that contain carcinogens that are directly affecting the health of firefighters. The turnout gear is currently stored in the apparatus bays where the apparatus expels carcinogens directly onto cleaned turnout gear. There is no tailpipe exhaust removal system in the apparatus bays. There are no decontamination showers for firefighters to decontaminate.
