LAKEVILLE

Fire Department Facilities Study

October 12, 2023

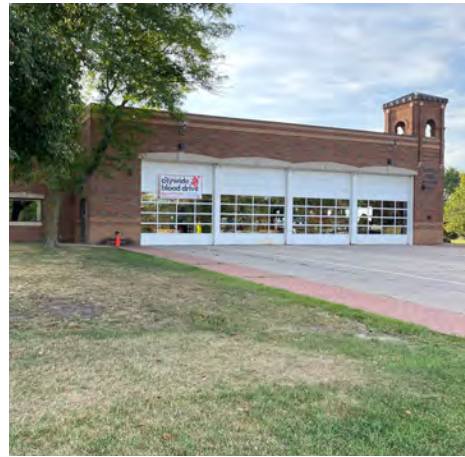
Infrastructure

The existing site layout does not provide adequate circulation and traffic flow. There is a drive that extends from this site directly north to the Heritage Center that does not need to be maintained. The site does have room for building and parking expansion. There is not separate public and firefighter parking. The current public parking is accessed from the same drives used for apparatus returning to the station which is not ideal.

Apparatus are unable to move between the west and east sides of the site without exiting onto either Holyoke Avenue or 202nd Street West/County Road 50 to re-enter the site.

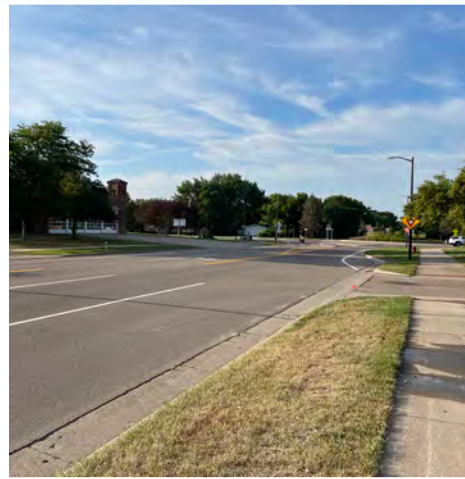
Station Access/Response Time

The apparatus return off of Holyoke Avenue and 202nd Street West/County Road 50. The apparatus respond onto Holyoke Avenue towards the west. There is a roundabout at the intersection of Holyoke Avenue and 202nd Street West/County Road 50 on the southwest corner of the site. When apparatus have their lights and sirens on, vehicles tend to stop in the roundabout affecting response time. There is a fire truck warning sign north of the station for vehicles heading south on Holyoke Avenue.

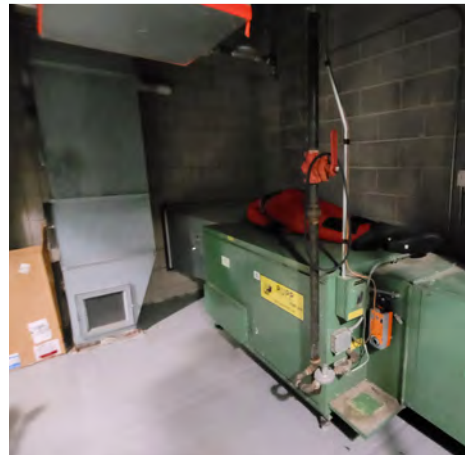
Maintenance

The mechanical and electrical systems have reached the end of their life cycle and need to be replaced. The generator does not provide full building coverage, so a new generator with full building coverage is required.

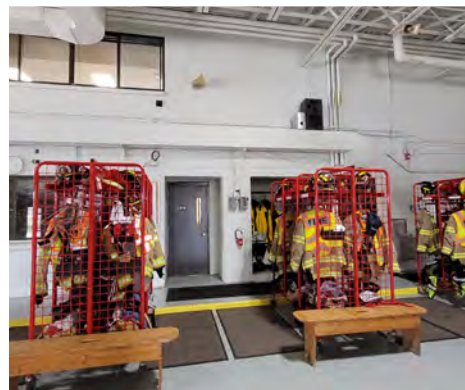
Health & Safety

The existing station raises several health and safety concerns for the firefighters that utilize the station. There is currently cross contamination between spaces and items that contain carcinogens that are directly affecting the health of firefighters. The turnout gear is currently stored in the apparatus bays where the apparatus expels carcinogens directly onto cleaned turnout gear. There is no tailpipe exhaust removal system in the apparatus bays. There is no true separate decontamination area for firefighters to decontaminate or clean gear and equipment. There is a curb between the station area and apparatus bays which is a trip hazard.

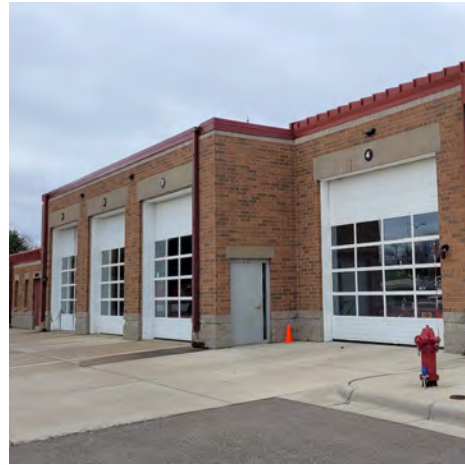
Infrastructure

The existing site layout does not provide adequate circulation and traffic flow. The site does have some room for building and parking expansion, but the drive locations are limited due to the location of the roundabout. The current public parking is accessed from the same drives used for apparatus returning to the station which is not ideal.

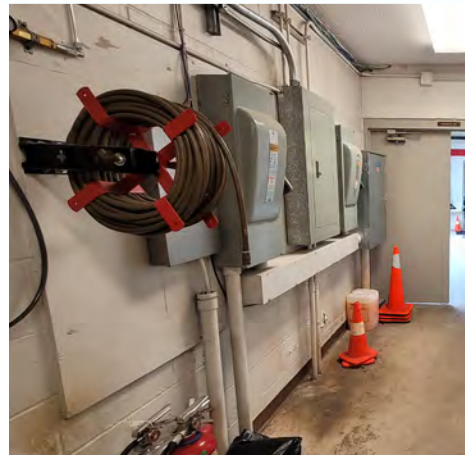
Maintenance

The mechanical systems consist of a furnace only and no rooftop units. The mechanical and electrical systems have reached the end of their life cycle and need to be replaced. The generator does not provide full building coverage, so a new generator with full building coverage is required.

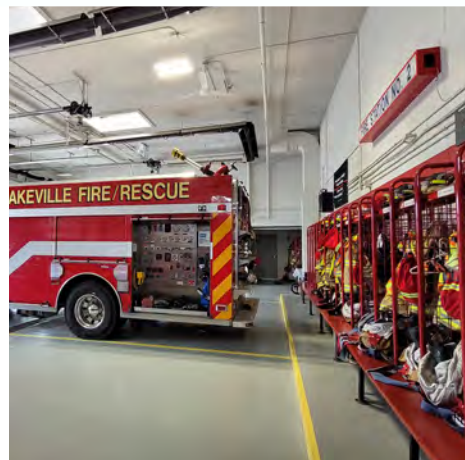
Health & Safety

The existing station raises several health and safety concerns for the firefighters that utilize the station. There is currently cross contamination between spaces and items that contain carcinogens that are directly affecting the health of firefighters. The turnout gear is currently stored in the apparatus bays where the apparatus expels carcinogens directly onto cleaned turnout gear. There is no tailpipe exhaust removal system in the apparatus bays. There is no true separate decontamination area for firefighters to decontaminate or clean gear and equipment and there is no shower in the station for decontamination. There is a curb between the station area and apparatus bays which is a trip hazard.

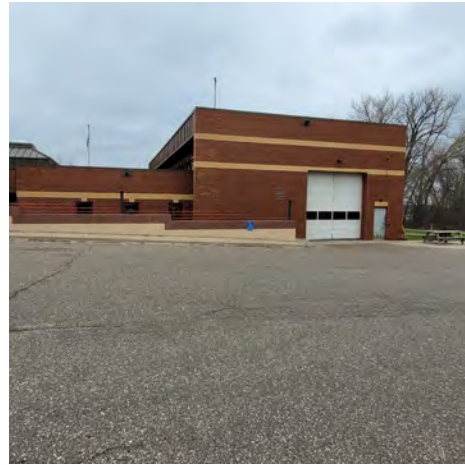
Infrastructure

The existing site layout does not provide adequate circulation and traffic flow. The site does not have room for building and parking expansion, but the existing communications building restricts where the expansions can be. The drive locations are limited due to the location of the roundabout and the pond just south of the site. The current public parking is accessed from the same drives used for apparatus returning to the station which is not ideal. Apparatus are unable to move between the west and east sides of the site without exiting onto Kenrick Avenue to re-enter the site via a separate drive.

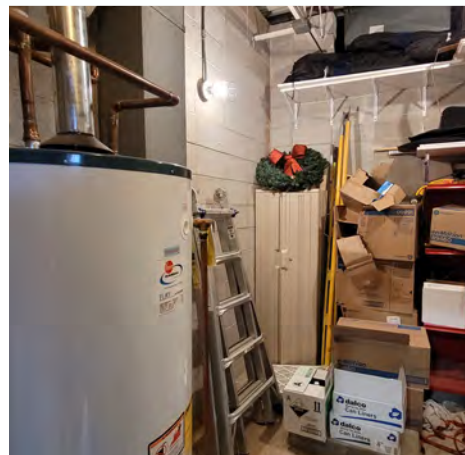
Maintenance

The mechanical and electrical systems have reached the end of their life cycle and need to be replaced. The generator does not provide full building coverage, so a new generator with full building coverage is required.

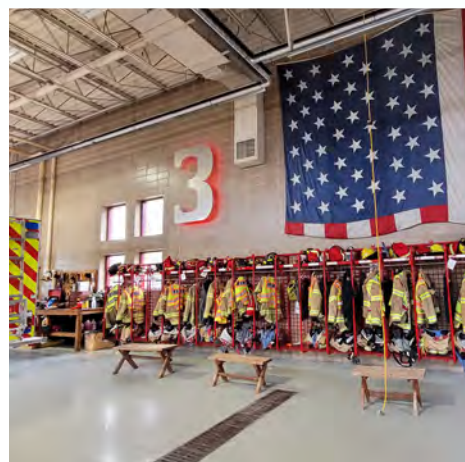
Health & Safety

The existing station raises several health and safety concerns for the firefighters that utilize the station. There is currently cross contamination between spaces and items that contain carcinogens that are directly affecting the health of firefighters. The turnout gear is currently stored in the apparatus bays where the apparatus expels carcinogens directly onto cleaned turnout gear. There is no tailpipe exhaust removal system in the apparatus bays. There is no true separate decontamination area for firefighters to decontaminate or clean gear and equipment. There is a curb between the station area and apparatus bays which is a trip hazard.

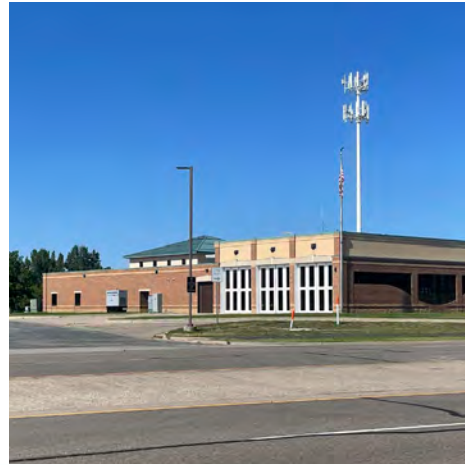
Infrastructure

The existing site layout does provide adequate circulation and traffic flow. The site does have room for building and parking expansion. There is not separate public and firefighter parking and the current public parking is accessed from the same drives used for apparatus returning to the station which is not ideal.

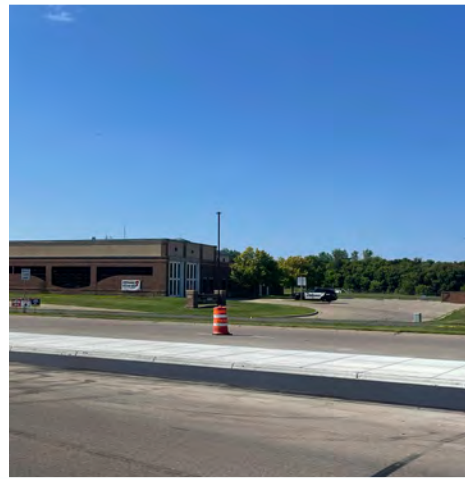
Station Access/Response Time

The apparatus return and respond off of the drive to the west of the station. When responding, the apparatus head south on the drive to 185th Street West where there is surmountable curb for the divided four lane road to respond east or west. There are fire truck warning signs in both directions on 185th Street West.

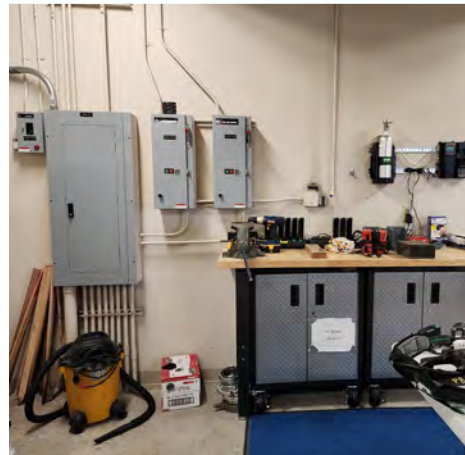
Maintenance

The mechanical and electrical systems have reached the end of their life cycle and need to be replaced. The generator does not provide full building coverage, but is more than likely not sized appropriately to cover additional loading that would occur with expanding the building size and would need to be replaced.

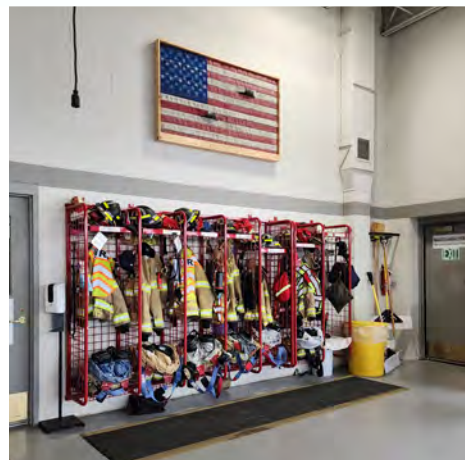
Health & Safety

The existing station raises several health and safety concerns for the firefighters that utilize the station. There is currently cross contamination between spaces and items that contain carcinogens that are directly affecting the health of firefighters. The turnout gear is currently stored in the apparatus bays where the apparatus expels carcinogens directly onto cleaned turnout gear. There is no tailpipe exhaust removal system in the apparatus bays. There are no decontamination showers for firefighters to decontaminate.
