Fire Department Facility Study by CNH Architects

Fire Department Facilities Study

October 12, 2023

CNH Architects

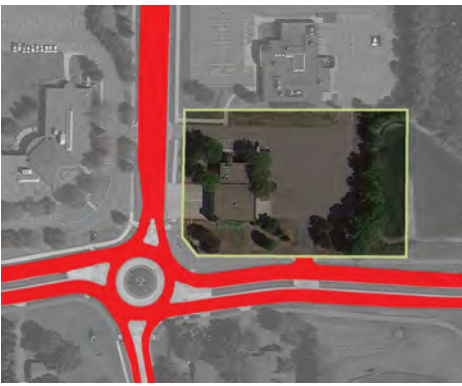
Street Access - Safety

The site is located at the intersection of Holyoke Avenue and 202nd Street West/County Road 50. There is good visibility of the site for apparatus to exit onto Holyoke Avenue. There is a roundabout at the southwest corner of the site at Holyoke Avenue and 202nd Street West/County Road 50, which does pose a safety issue for apparatus responding as vehicles tend to stop in the roundabout.

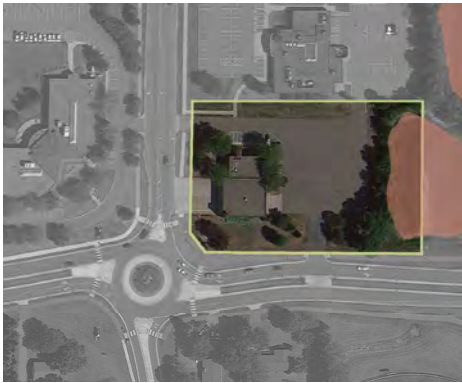
Wetlands

There is a wetland located on the east side of the property.

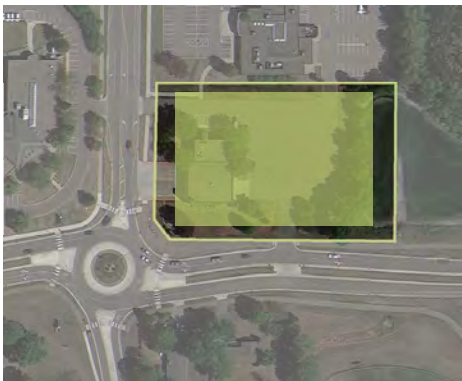
Buildable Area

The site is approximately 4.25 acres. 2.11 acres are buildable, but the wetland to the east reduces that some.

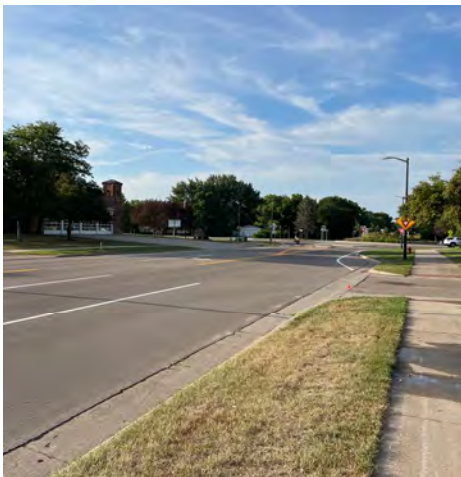
Station Access/Response Time

The apparatus return off of Holyoke Avenue and 202nd Street West/County Road 50. The apparatus respond onto Holyoke Avenue towards the west. There is a roundabout at the intersection of Holyoke Avenue and 202nd Street West/County Road 50 on the southwest corner of the site. When apparatus have their lights and sirens on, vehicles tend to stop in the roundabout affecting response time. There is a fire truck warning sign north of the station for vehicles heading south on Holyoke Avenue.

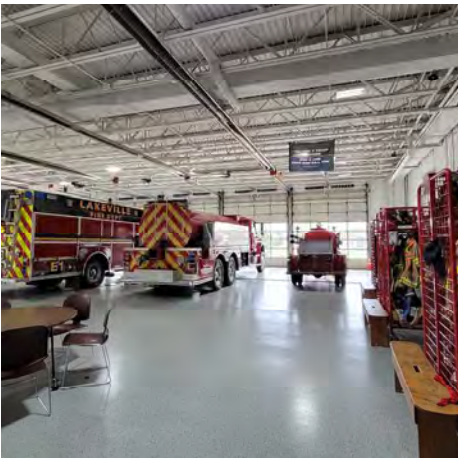
Insufficient Space

The existing station has spaces that are currently too small for day-to-day operations including the SCBA, laundry/gear wash/decon, and storage. There is not enough room in the current station to create additional spaces that are needed for operational use such as individual dorms and restrooms, separate turnout gear, separate gear wash/decontamination, separate laundry, decontamination restrooms/showers, training space, and fitness

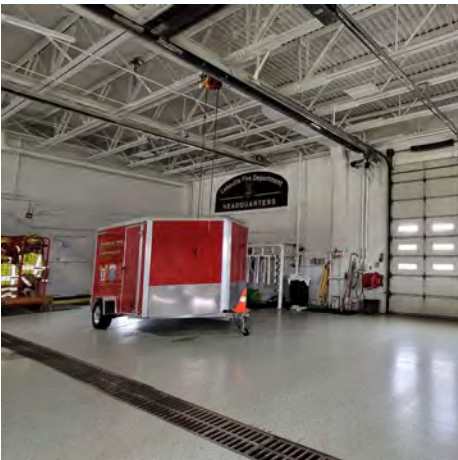
Fire Department Operations

Day-to-day operations of the fire department have changed over the years and the current fire station does not meet the needs of the department. As the department switches from a paid-on-call model to a hybrid model with some full-time staff, the station is not set up to accommodate dorm rooms and restrooms. There is space for classroom style training, but no space for other types of training. There are four existing apparatus bays, but only two are drive-through bays. The other two apparatus bays are back-in bays which are not ideal.

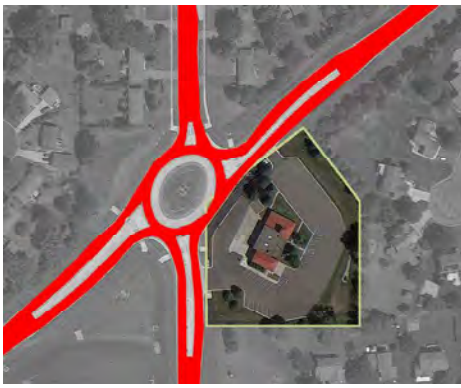
Street Access - Safety

The site is located at the intersection of Dodd Boulevard and Flagstaff Avenue. There is good visibility of the site for apparatus to exit onto Flagstaff Avenue. There is a roundabout at the northwest corner of the site at Dodd Boulevard and Flagstaff Avenue, which does pose a safety issue for apparatus responding as vehicles tend to stop in the roundabout.

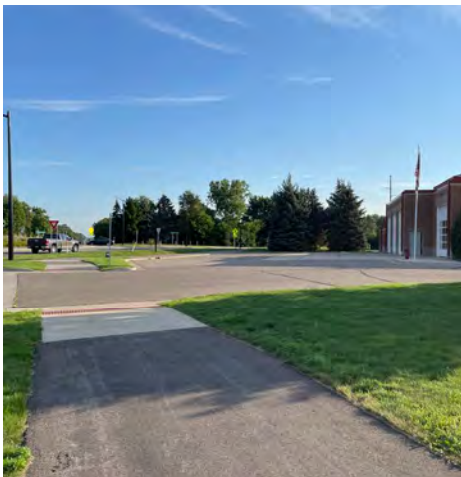
Infrastructure

The existing site layout does not provide adequate circulation and traffic flow. The site does have some room for building and parking expansion, but the drive locations are limited due to the location of the roundabout. The current public parking is accessed from the same drives used for apparatus returning to the station which is not ideal.

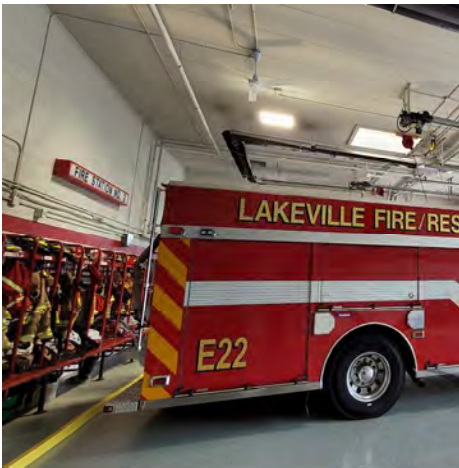
Health & Safety

The existing station raises several health and safety concerns for the firefighters that utilize the station. There is currently cross contamination between spaces and items that contain carcinogens that are directly affecting the health of firefighters. The turnout gear is currently stored in the apparatus bays where the apparatus expels carcinogens directly onto cleaned turnout gear. There is no tailpipe exhaust removal system in the apparatus bays. There is no true separate decontamination area for firefighters to decontaminate or clean gear and equipment and there is no shower in the station for decontamination. There is a curb between the station area and apparatus bays which is a trip hazard.

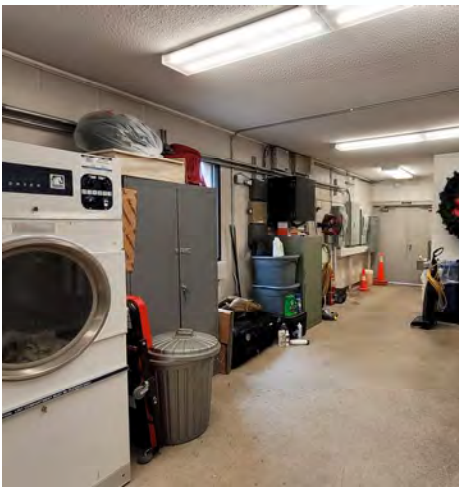
Insufficient Space

The existing station has many spaces that are currently too small for day-to-day operations including the apparatus bays, SCBA/laundry/gear wash/decon, and storage. There is not enough room in the current station to create additional spaces that are needed for operational use such as individual dorms and restrooms, separate turnout gear, separate gear wash/decontamination, separate laundry, separate SCBA, decontamination restrooms/showers, training space, and fitness.

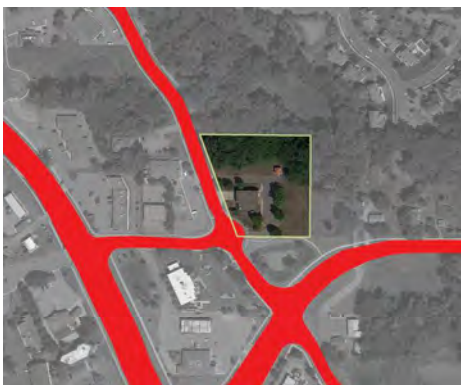
Street Access - Safety

The site is located at the intersection of Kenrick Avenue and 175th Street West. There is good visibility of the site for apparatus to exit onto Kenrick Avenue. There is a roundabout at the southwest corner of the site at Kenrick Avenue and 175th Street West, which does pose a safety issue for apparatus responding as vehicles tend to stop in the roundabout.

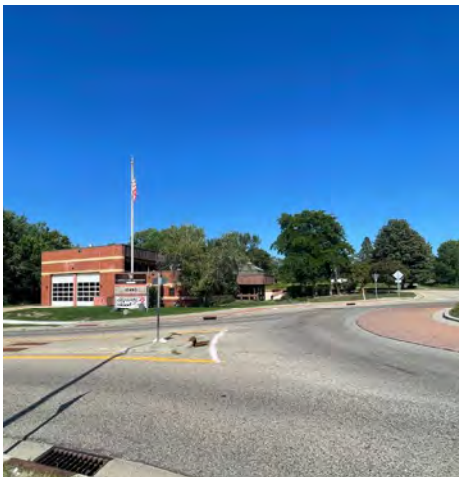
Infrastructure

The existing site layout does provide adequate circulation and traffic flow. The site does have room for building and parking expansion, but the existing communications building restricts where the expansions can be. The drive locations are limited due to the location of the roundabout and the pond just south of the site. The current public parking is accessed from the same drives used for apparatus returning to the station which is not ideal. Apparatus are unable to move between the west and east sides of the site without exiting onto Kenrick Avenue to re-enter the site via a separate drive.

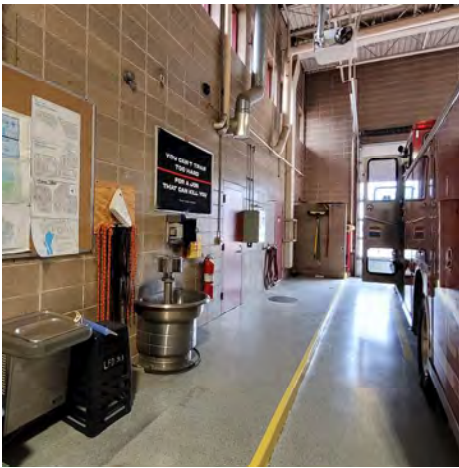
Health & Safety

The existing station raises several health and safety concerns for the firefighters that utilize the station. There is currently cross contamination between spaces and items that contain carcinogens that are directly affecting the health of firefighters. The turnout gear is currently stored in the apparatus bays where the apparatus expels carcinogens directly onto cleaned turnout gear. There is no tailpipe exhaust removal system in the apparatus bays. There is no true separate decontamination area for firefighters to decontaminate or clean gear and equipment. There is a curb between the station area and apparatus bays which is a trip hazard.

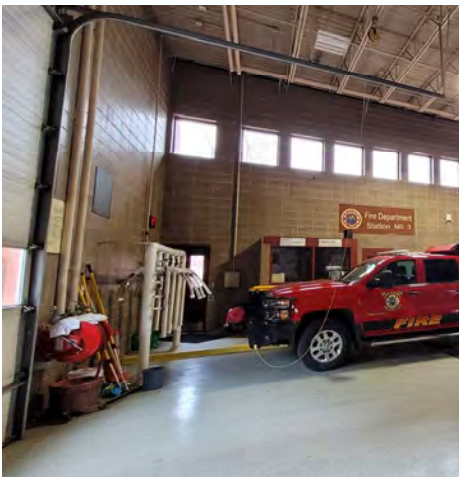
Insufficient Space

The existing station has many spaces that are currently too small for day-to-day operations including the SCBA/laundry/gear wash/decon, dayroom, and storage. There is not enough room in the current station to create additional spaces that are needed for operational use such as individual dorms and restrooms, separate turnout gear, separate gear wash/decontamination, separate laundry, separate SCBA, decontamination restrooms/showers, training space, and fitness.

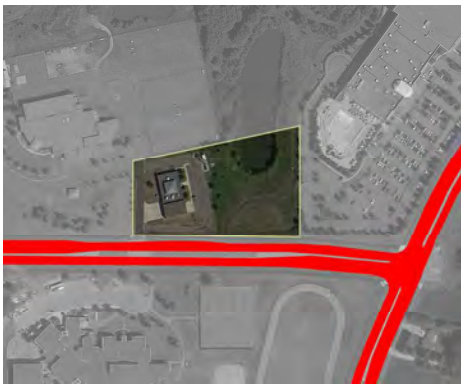
Street Access - Safety

This site is located on the north side of 185th Street West between Ipava Avenue and Dodd Boulevard. There is good visibility of the site for apparatus to exit onto 185th Street West. 185th Street West is a four lane divided road with surmountable curb for apparatus to respond east or west.

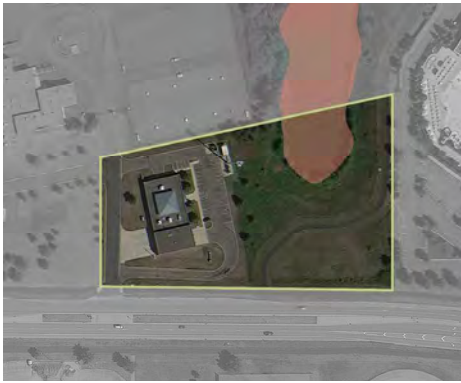
Wetlands

There is a wetland located on a portion of the northeast corner of the property.

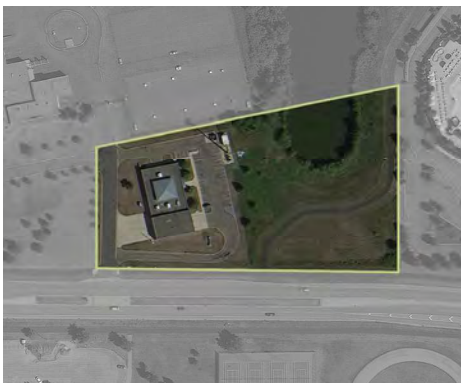
Tree Coverage Map

There are a few trees scattered on site around the building and east of the parking lot. There is a line of trees around the wetland.

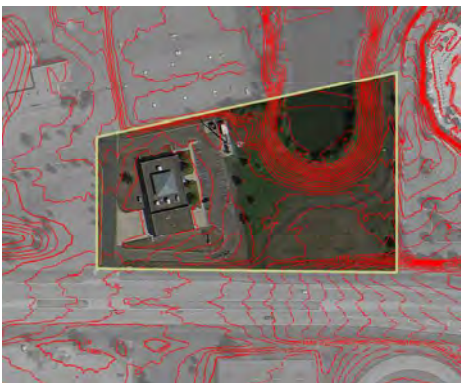
Topography

The topography is fairly flat across the site where the building and parking lot are. The topography slopes down at the north property line and towards the wetland.

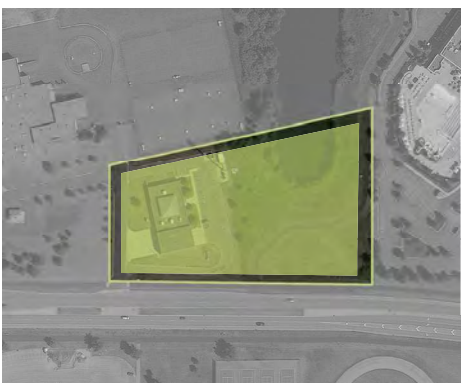
Buildable Area

The site is approximately 5.06 acres. 4.04 acres are buildable although the wetland takes up a portion of this buildable space. The size of the buildable area provides room to expand towards the east.

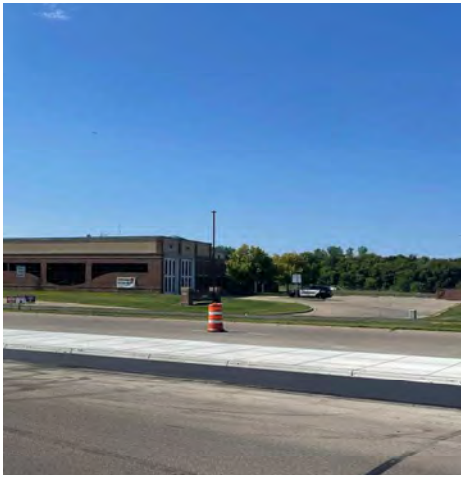
Station Access/Response Time

The apparatus return and respond off of the drive to the west of the station. When responding, the apparatus head south on the drive to 185th Street West where there is surmountable curb for the divided four lane road to respond east or west. There are fire truck warning signs in both directions on 185th Street West.

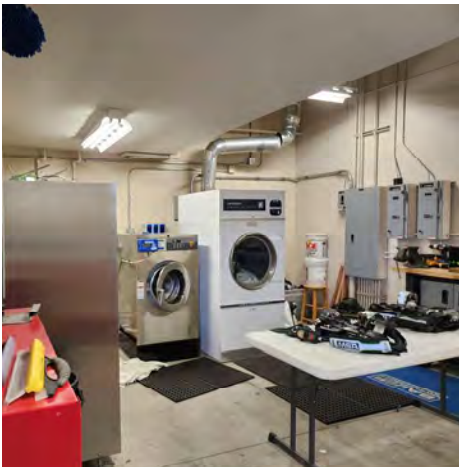
Insufficient Space

The existing station has many spaces that are currently too small for day-to-day operations including the two short bays, SCBA/laundry/gear wash/decon, and storage. There is not enough room in the current station to create additional spaces that are needed for operational use such as individual dorms and restrooms, separate turnout gear, separate gear wash/decontamination, separate laundry, separate SCBA, and decontamination restrooms/showers.

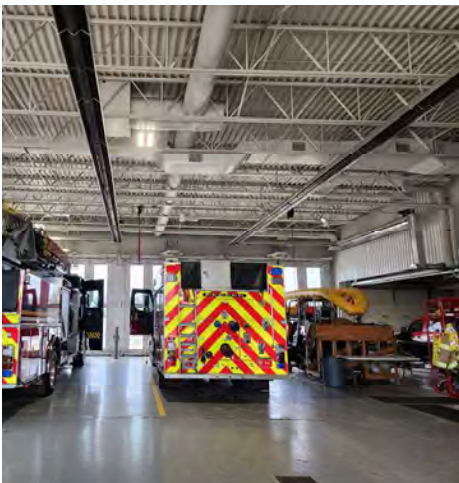
Fire Department Operations

Day-to-day operations of the fire department have changed over the years and the current fire station does not meet the needs of the department. As the department switches from a paid-on-call model to a hybrid model with some full-time staff, the station is not set up to accommodate dorm rooms and restrooms. There is space for classroom style training, but no space for other types of training. There are four existing apparatus bays, but only two are drive-through bays and the other two are short back-in bays which are not ideal.

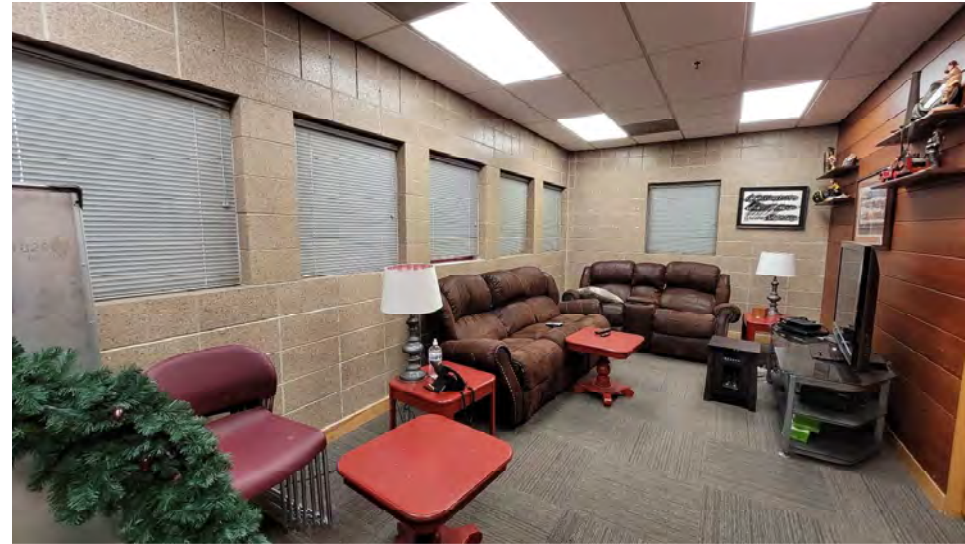
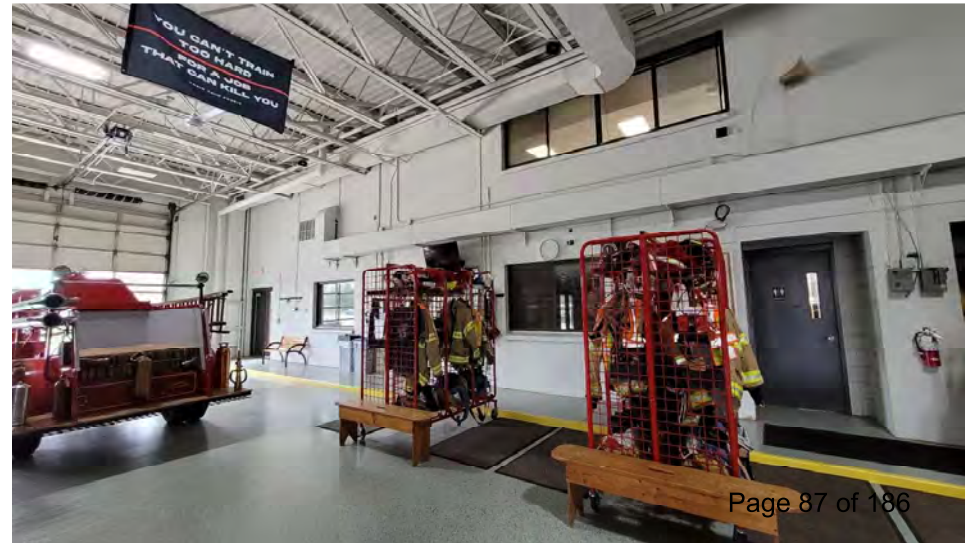
Firefighter Health

Does Not Meet Need For:

- › Carcinogen separation
- › Vehicle exhaust extraction

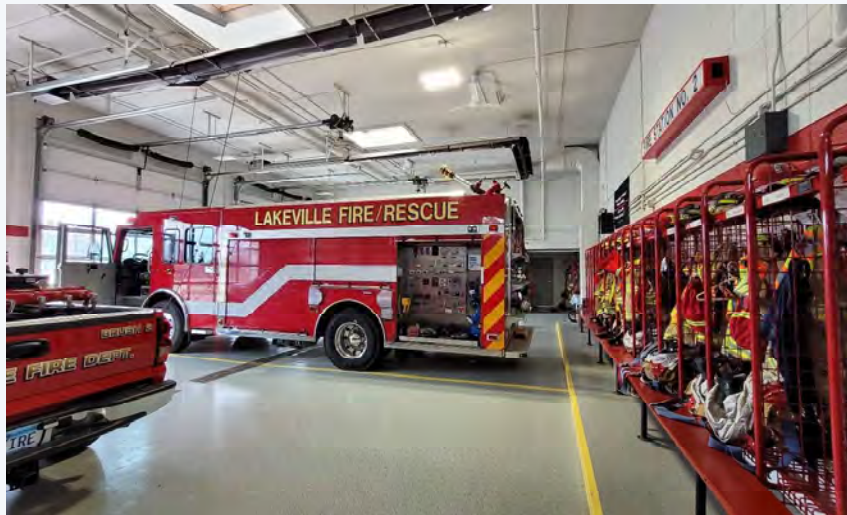
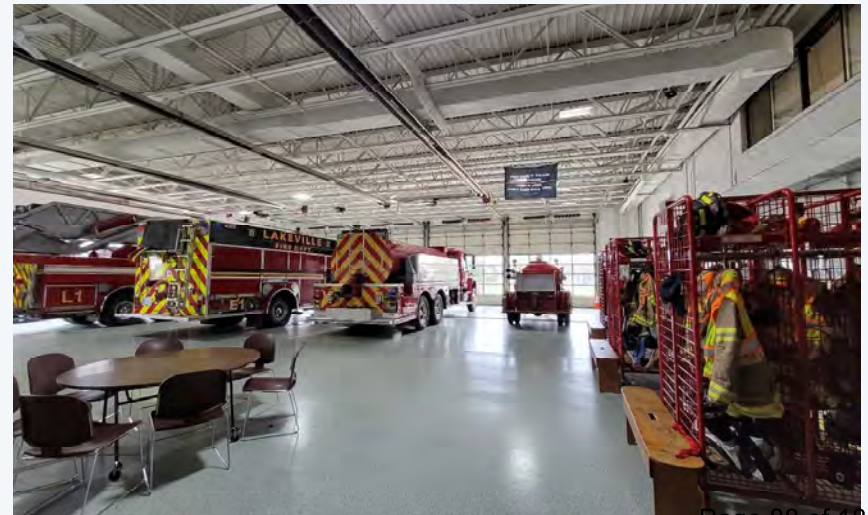
Firefighter Health

Does Not Meet Need For:

- › Adequate decontamination
- › Separate turnout gear space

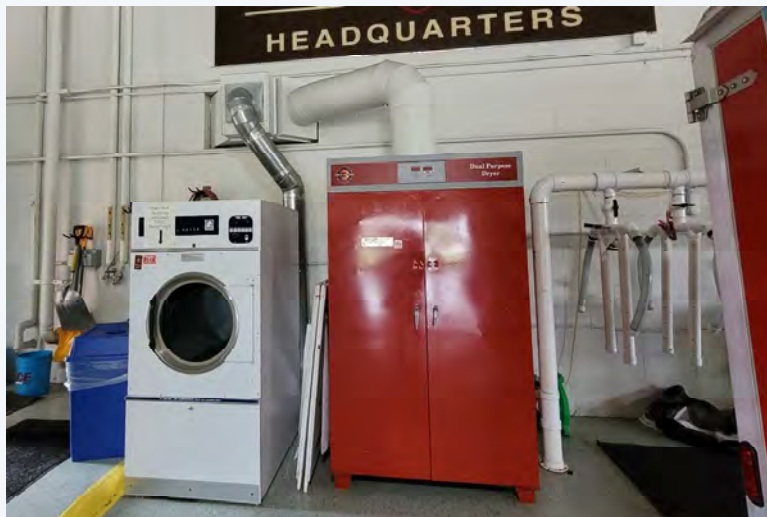
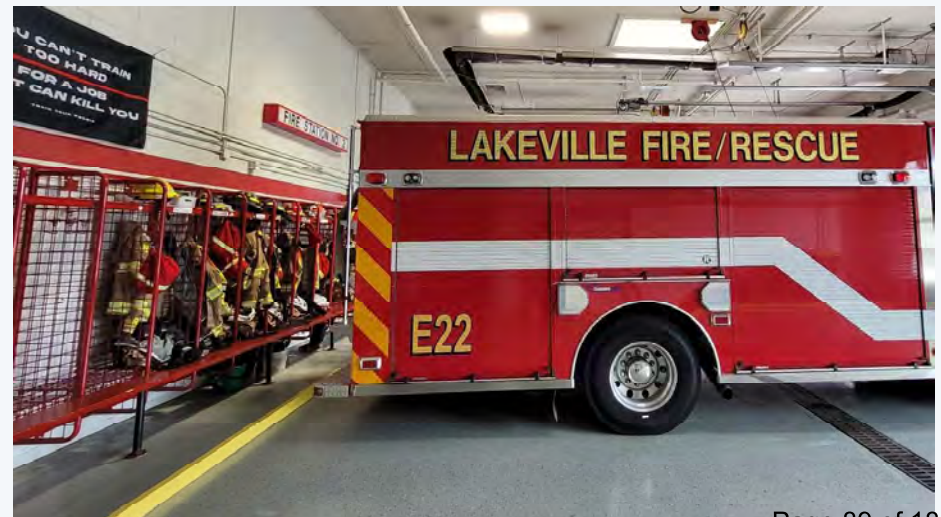
Firefighter Health

Does Not Meet Need For:

- › Mental health support
- › Indoor / outdoor fitness space

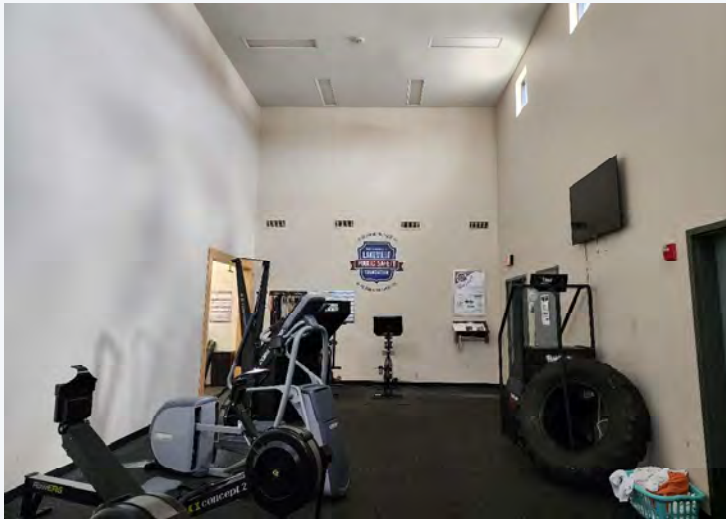
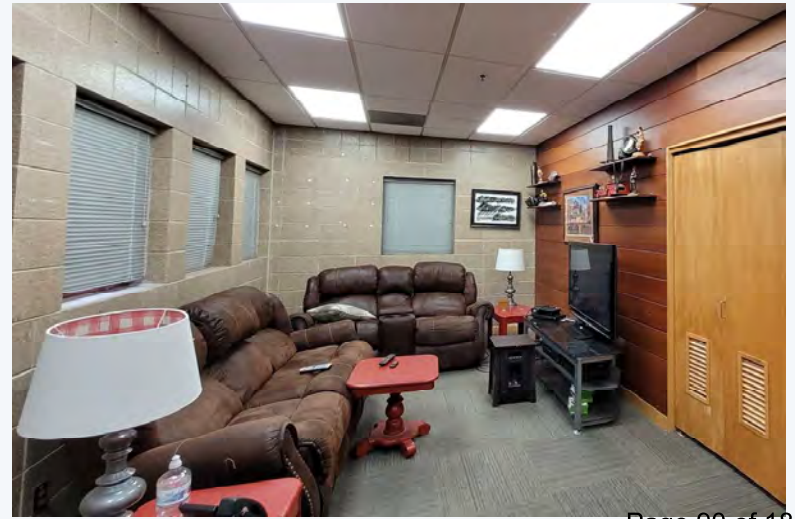
Firefighter Health

Does Not Meet Need For:

- › Lack of dorms
- › Controlled lighting transitions

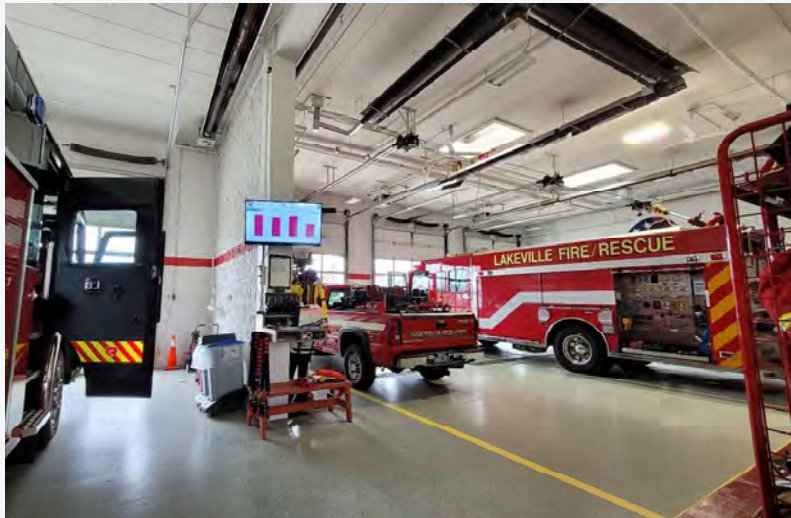
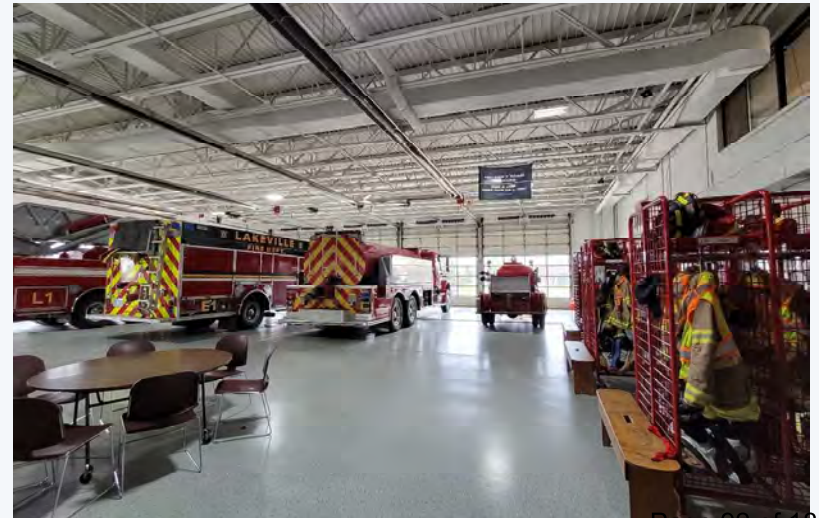
Safety

Does Not Meet Need For:

- › Station design Best Practices
- › Current building codes
- › Sufficient clearance around apparatus

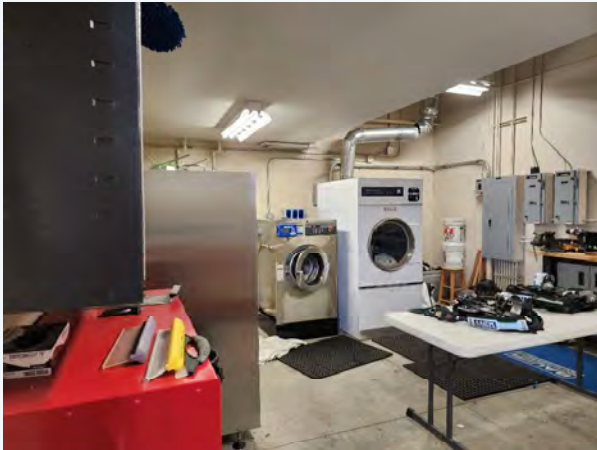
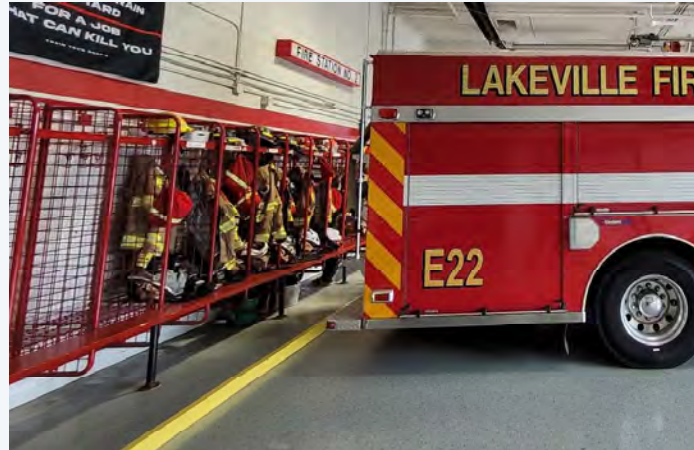
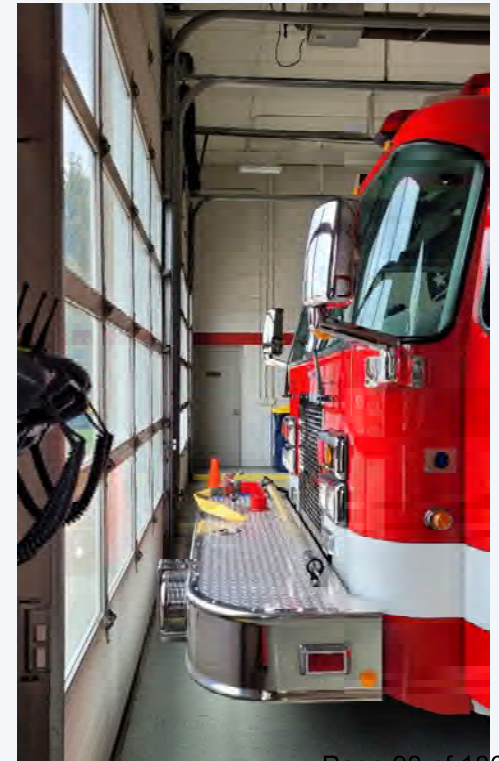
Training

Does Not Meet Need For:

- › Ground ladder training/evolutions
- › Hose advancement/stair evolutions

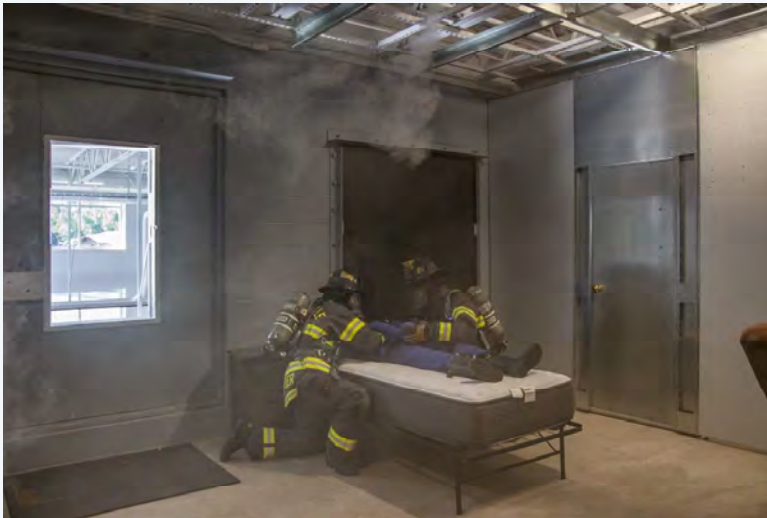
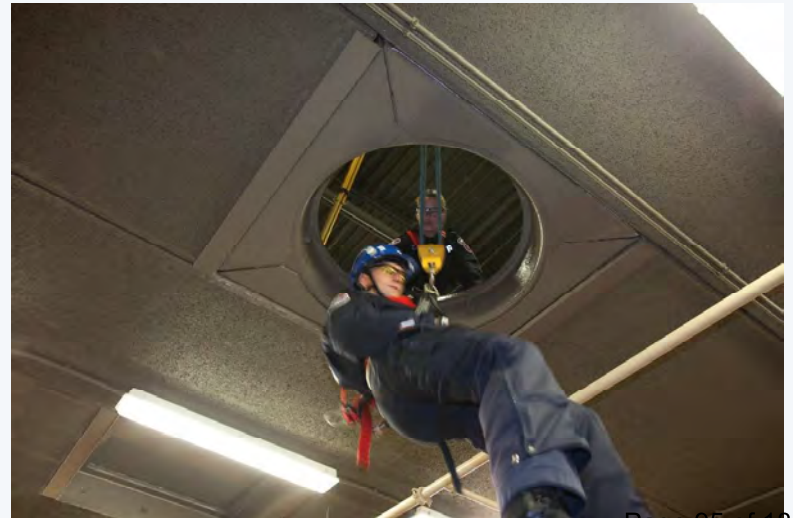
Training

Does Not Meet Need For:

- › High rise training
- › Wall/floor breach

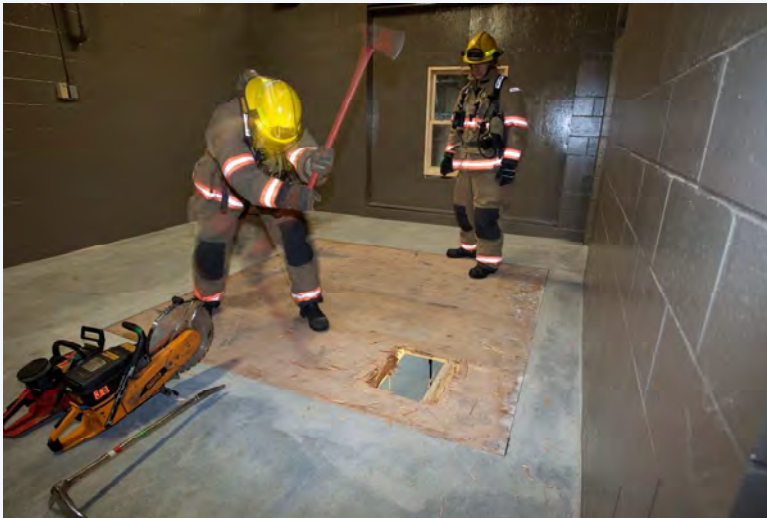
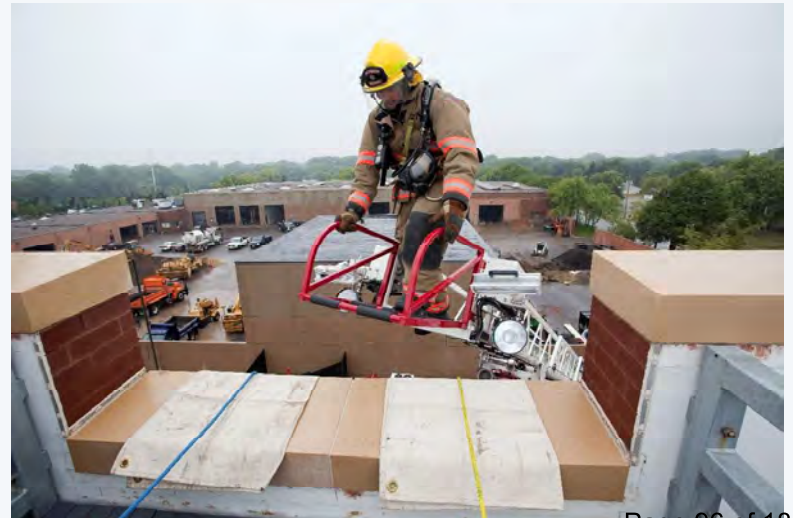
Training

Does Not Meet Need For:

- › Advanced technical rescue (rope rescue/rappelling)
- › Alarm panel/sprinkler system

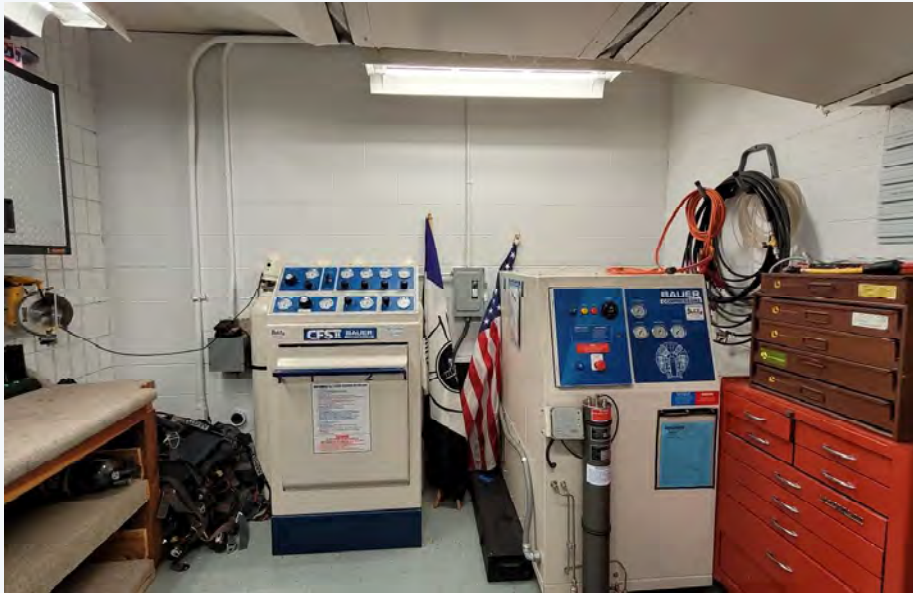
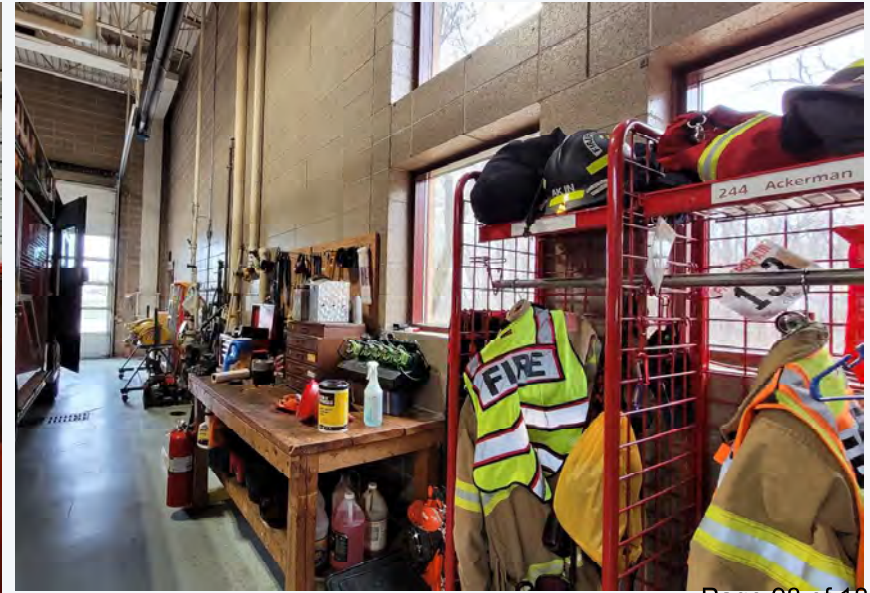
Shortage of Space

- › Site & building not functionally organized
- › Inefficient operational flow
