LAKEVILLE

Fire Department Facilities Study

October 12, 2023

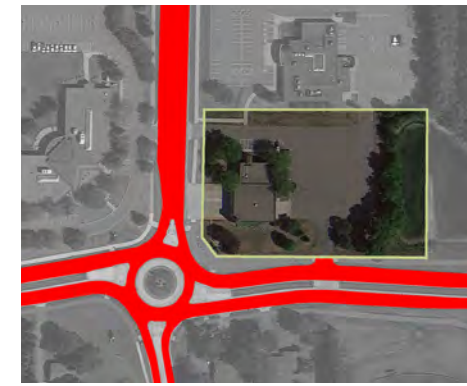
Street Access - Safety

The site is located at the intersection of Holyoke Avenue and 202nd Street West/County Road 50. There is good visibility of the site for apparatus to exit onto Holyoke Avenue. There is a roundabout at the southwest corner of the site at Holyoke Avenue and 202nd Street West/County Road 50, which does pose a safety issue for apparatus responding as vehicles tend to stop in the roundabout.

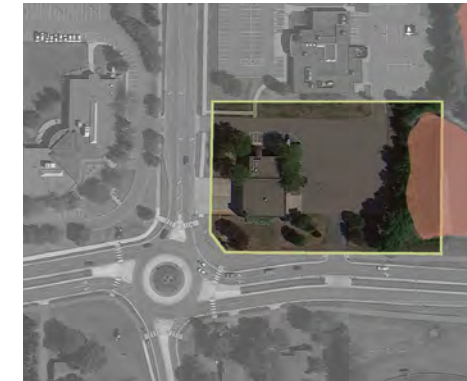
Wetlands

There is a wetland located on the east side of the property.

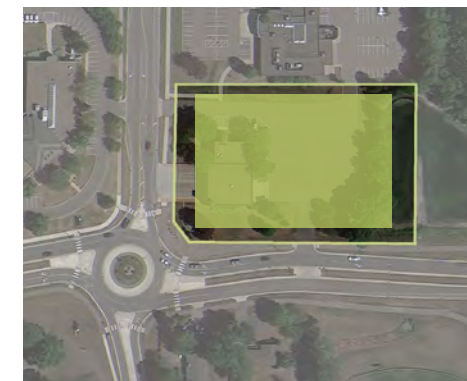
Buildable Area

The site is approximately 4.25 acres. 2.11 acres are buildable, but the wetland to the east reduces that some.

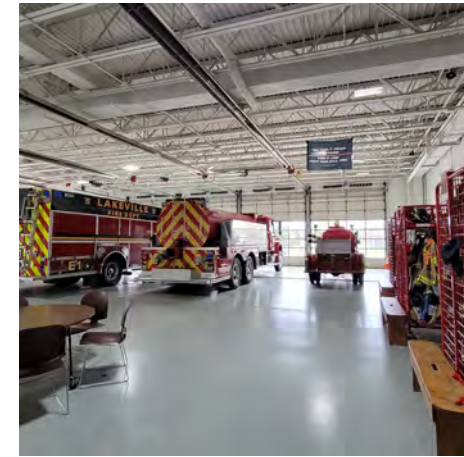
The existing station raises several health and safety concerns for the firefighters that utilize the station. There is currently cross contamination between spaces and items that contain carcinogens that are directly affecting the health of firefighters. The turnout gear is currently stored in the apparatus bays where the apparatus expels carcinogens directly onto cleaned turnout gear. There is no tailpipe exhaust removal system in the apparatus bays. There is no true separate decontamination area for firefighters to decontaminate or clean gear and equipment. There is a curb between the station area and apparatus bays which is a trip hazard.

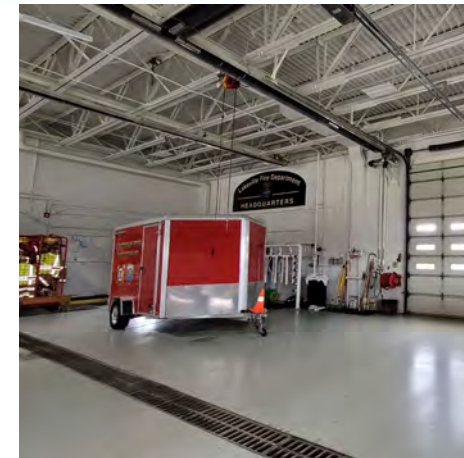
Insufficient Space

The existing station has spaces that are currently too small for day-to-day operations including the SCBA, laundry/gear wash/decon, and storage. There is not enough room in the current station to create additional spaces that are needed for operational use such as individual dorms and restrooms, separate turnout gear, separate gear wash/decontamination, separate laundry, decontamination restrooms/showers, training space, and fitness

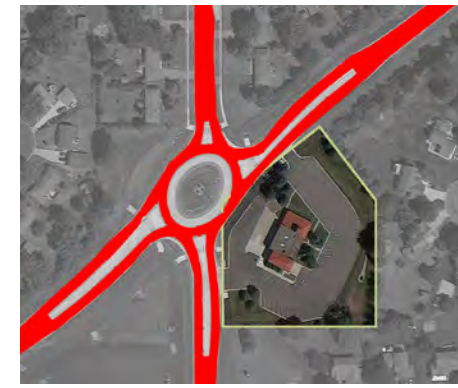
Street Access - Safety

The site is located at the intersection of Dodd Boulevard and Flagstaff Avenue. There is good visibility of the site for apparatus to exit onto Flagstaff Avenue. There is a roundabout at the northwest corner of the site at Dodd Boulevard and Flagstaff Avenue, which does pose a safety issue for apparatus responding as vehicles tend to stop in the roundabout.

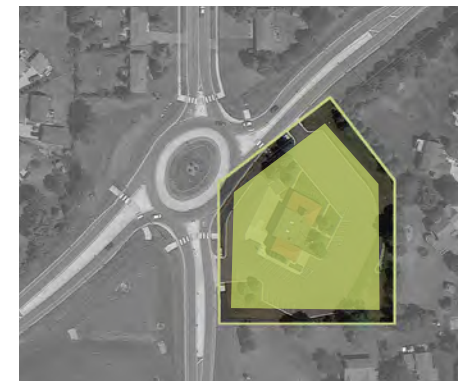
Buildable Area

The site is approximately 2.54 acres. 1.40 acres are buildable, but some of that buildable area is part of the roundabout.

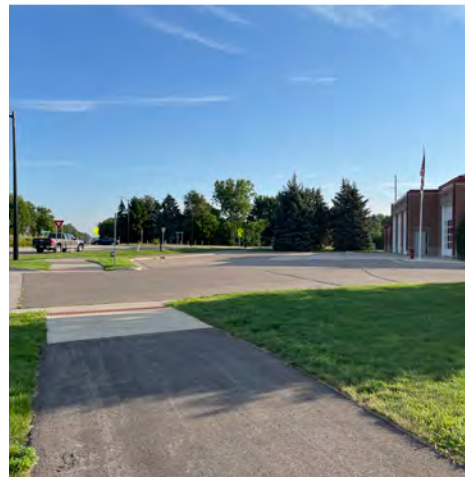
Infrastructure

The existing site layout does not provide adequate circulation and traffic flow. The site does have some room for building and parking expansion, but the drive locations are limited due to the location of the roundabout. The current public parking is accessed from the same drives used for apparatus returning to the station which is not ideal.

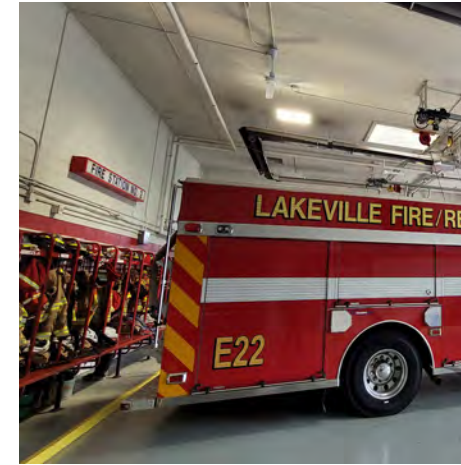
Health & Safety

The existing station raises several health and safety concerns for the firefighters that utilize the station. There is currently cross contamination between spaces and items that contain carcinogens that are directly affecting the health of firefighters. The turnout gear is currently stored in the apparatus bays where the apparatus expels carcinogens directly onto cleaned turnout gear. There is no tailpipe exhaust removal system in the apparatus bays. There is no true separate decontamination area for firefighters to decontaminate or clean gear and equipment and there is no shower in the station for decontamination. There is a curb between the station area and apparatus bays which is a trip hazard.

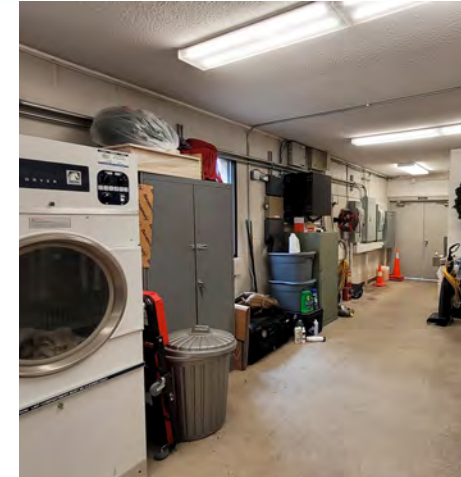
Insufficient Space

The existing station has many spaces that are currently too small for day-to-day operations including the apparatus bays, SCBA/laundry/gear wash/decon, and storage. There is not enough room in the current station to create additional spaces that are needed for operational use such as individual dorms and restrooms, separate turnout gear, separate gear wash/decontamination, separate laundry, separate SCBA, decontamination restrooms/showers, training space, and fitness.

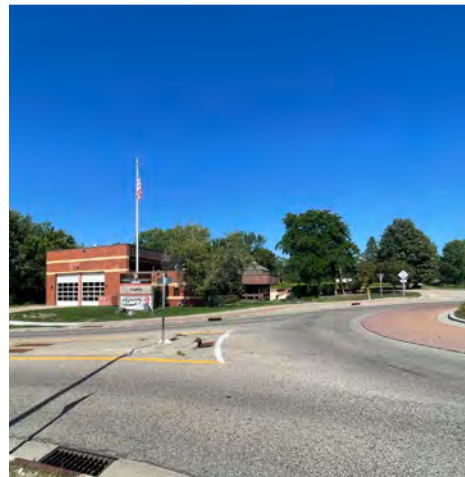
Infrastructure

The existing site layout does not provide adequate circulation and traffic flow. The site does not have room for building and parking expansion, but the existing communications building restricts where the expansions can be. The drive locations are limited due to the location of the roundabout and the pond just south of the site. The current public parking is accessed from the same drives used for apparatus returning to the station which is not ideal. Apparatus are unable to move between the west and east sides of the site without exiting onto Kenrick Avenue to re-enter the site via a separate drive.

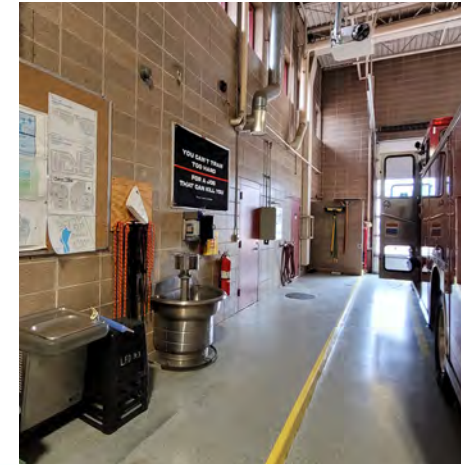
Health & Safety

The existing station raises several health and safety concerns for the firefighters that utilize the station. There is currently cross contamination between spaces and items that contain carcinogens that are directly affecting the health of firefighters. The turnout gear is currently stored in the apparatus bays where the apparatus expels carcinogens directly onto cleaned turnout gear. There is no tailpipe exhaust removal system in the apparatus bays. There is no true separate decontamination area for firefighters to decontaminate or clean gear and equipment. There is a curb between the station area and apparatus bays which is a trip hazard.

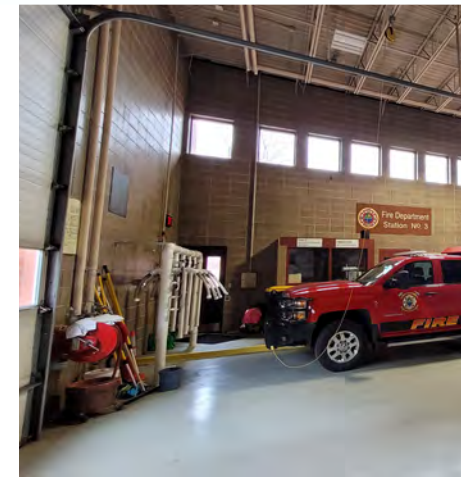
Insufficient Space

The existing station has many spaces that are currently too small for day-to-day operations including the SCBA/laundry/gear wash/decon, dayroom, and storage. There is not enough room in the current station to create additional spaces that are needed for operational use such as individual dorms and restrooms, separate turnout gear, separate gear wash/decontamination, separate laundry, separate SCBA, decontamination restrooms/showers, training space, and fitness.

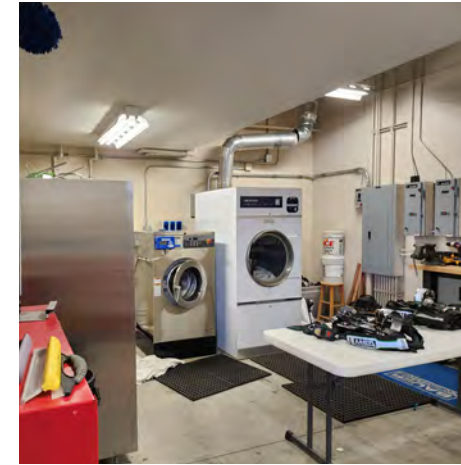
Health & Safety

The existing station raises several health and safety concerns for the firefighters that utilize the station. There is currently cross contamination between spaces and items that contain carcinogens that are directly affecting the health of firefighters. The turnout gear is currently stored in the apparatus bays where the apparatus expels carcinogens directly onto cleaned turnout gear. There is no tailpipe exhaust removal system in the apparatus bays. There are no decontamination showers for firefighters to decontaminate.
