ENGINEERING REPORT

2025 STREET REHABILITATION PROJECT

CITY PROJECT NO. 25-02

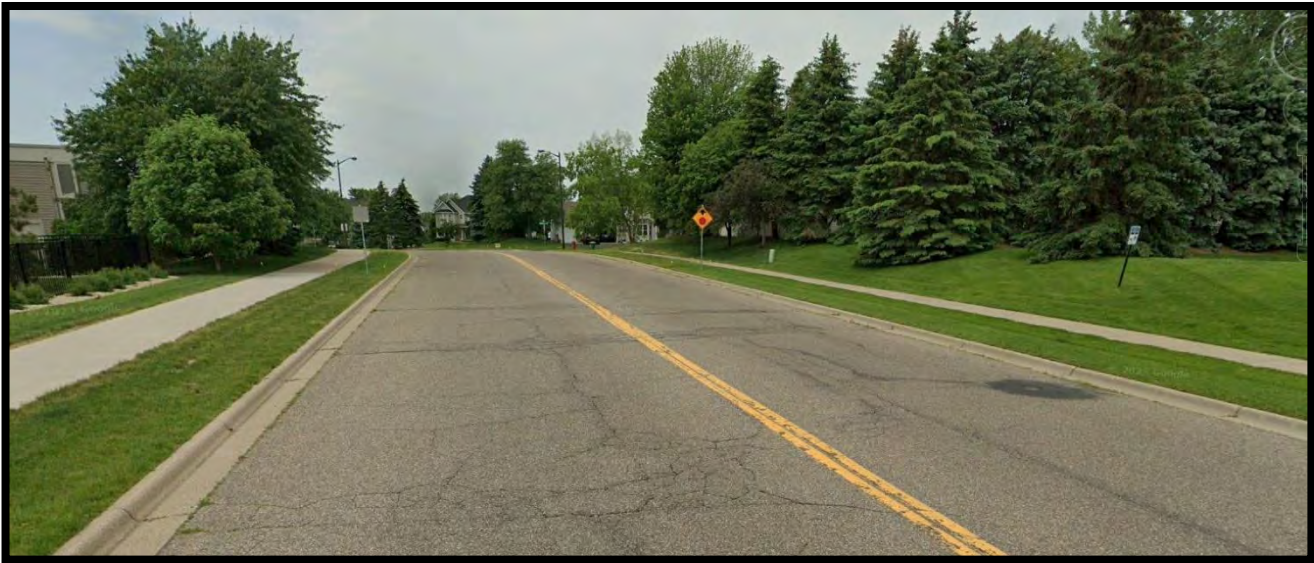
Photo 1. Glacier Way west towards 175th Street West.

Streets within the proposed improvement area are aging and experiencing differing severities of distress, including alligator, transverse, and longitudinal cracking. All streets within the project area are urbanized, with existing concrete curb and gutter. All of the curb and gutter is either full height curb or surmountable. The curb and gutter is in overall fair condition, with isolated instances of cracking, heaving, and settlements resulting in localized drainage issues.

The photos below illustrate some of the varying levels of pavement distress:

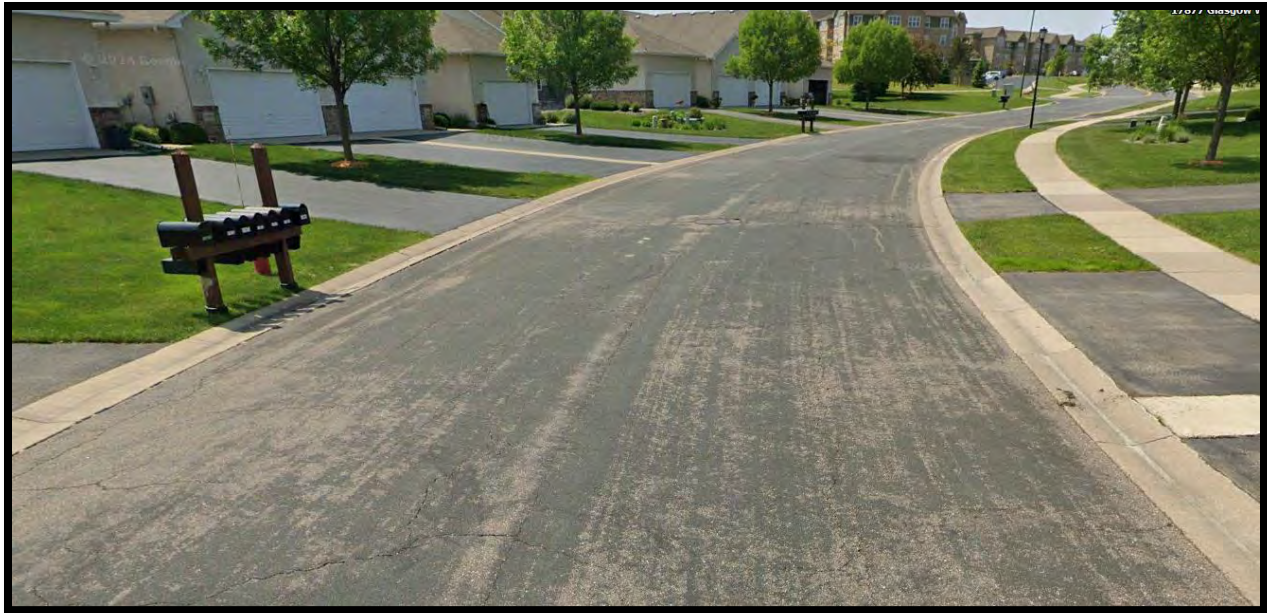
Photo 2. Glasgow Way looking west towards Glacier Way.

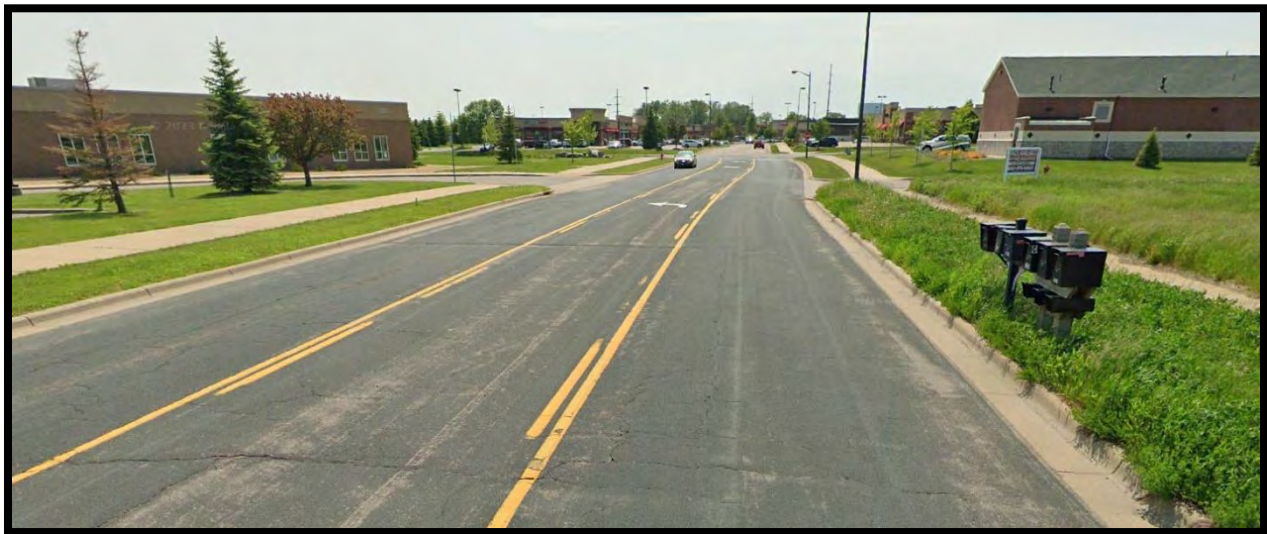
Photo 3. 175th Street West looking southwest towards Glasgow Avenue.

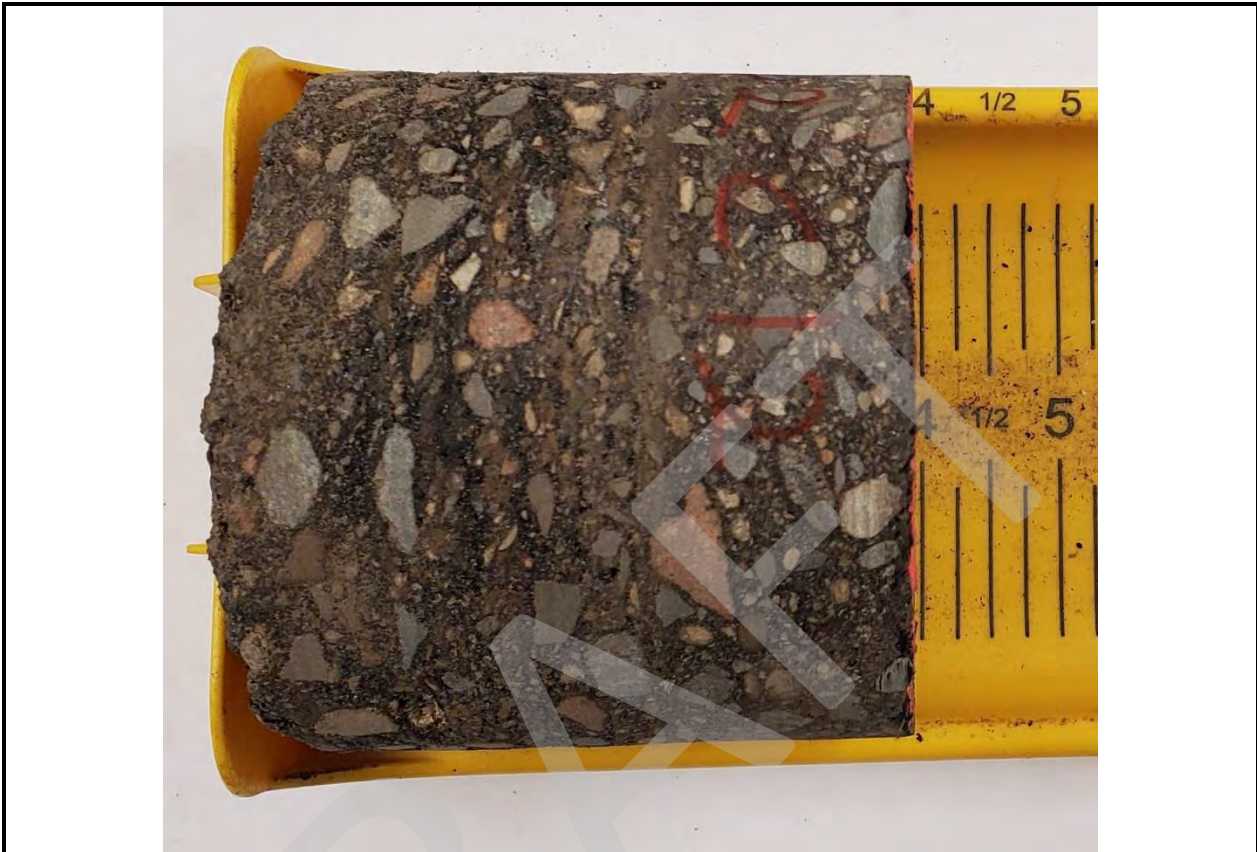
C-11A

Core Photo Log

We obtained core samples of the pavement using a portable coring machine advancing a 4-inch diameter core barrel. Immediately after completing the coring, we repaired the bituminous pavement with a coldmix bituminous patch. We measured the cores to obtain approximate bituminous thickness and noted their material conditions based on visual observation. The Appendix includes images of the cores.

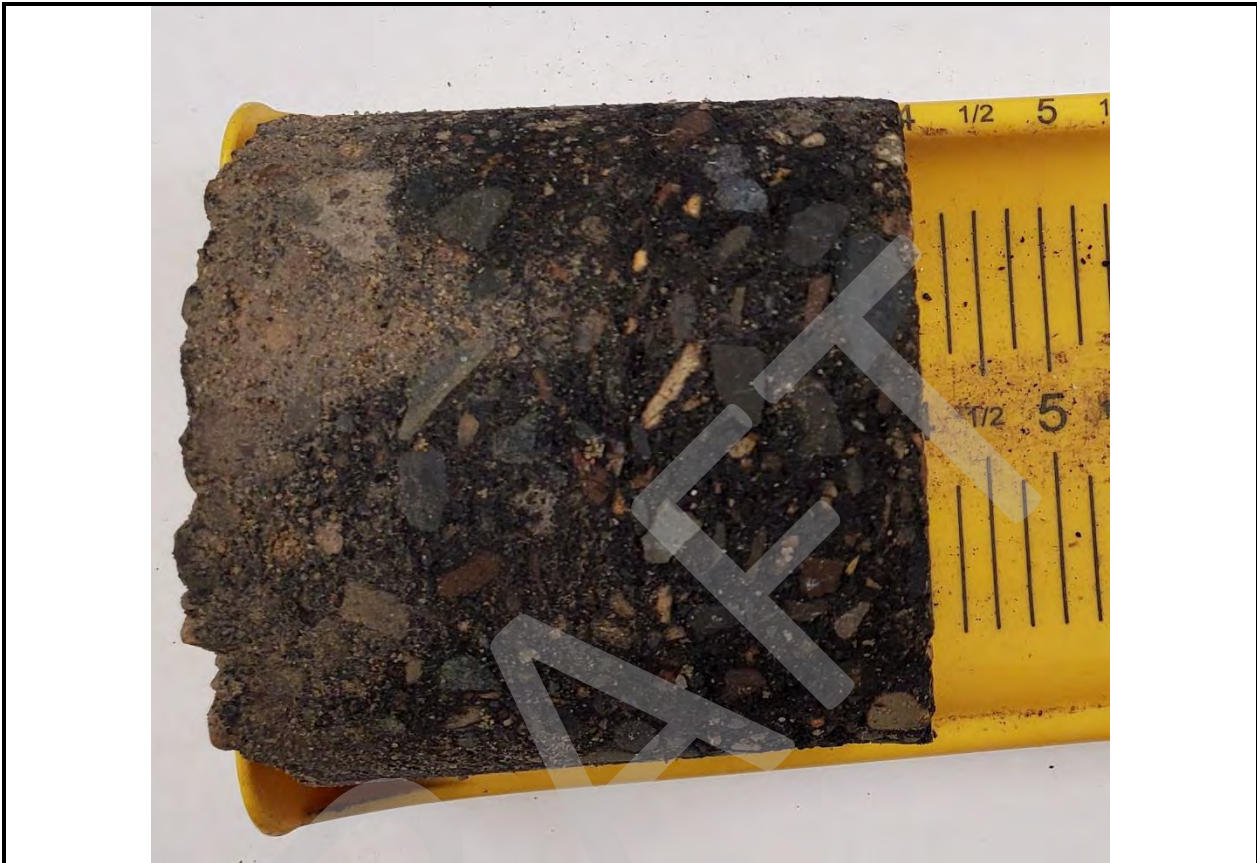
C-15

Core Photo Log

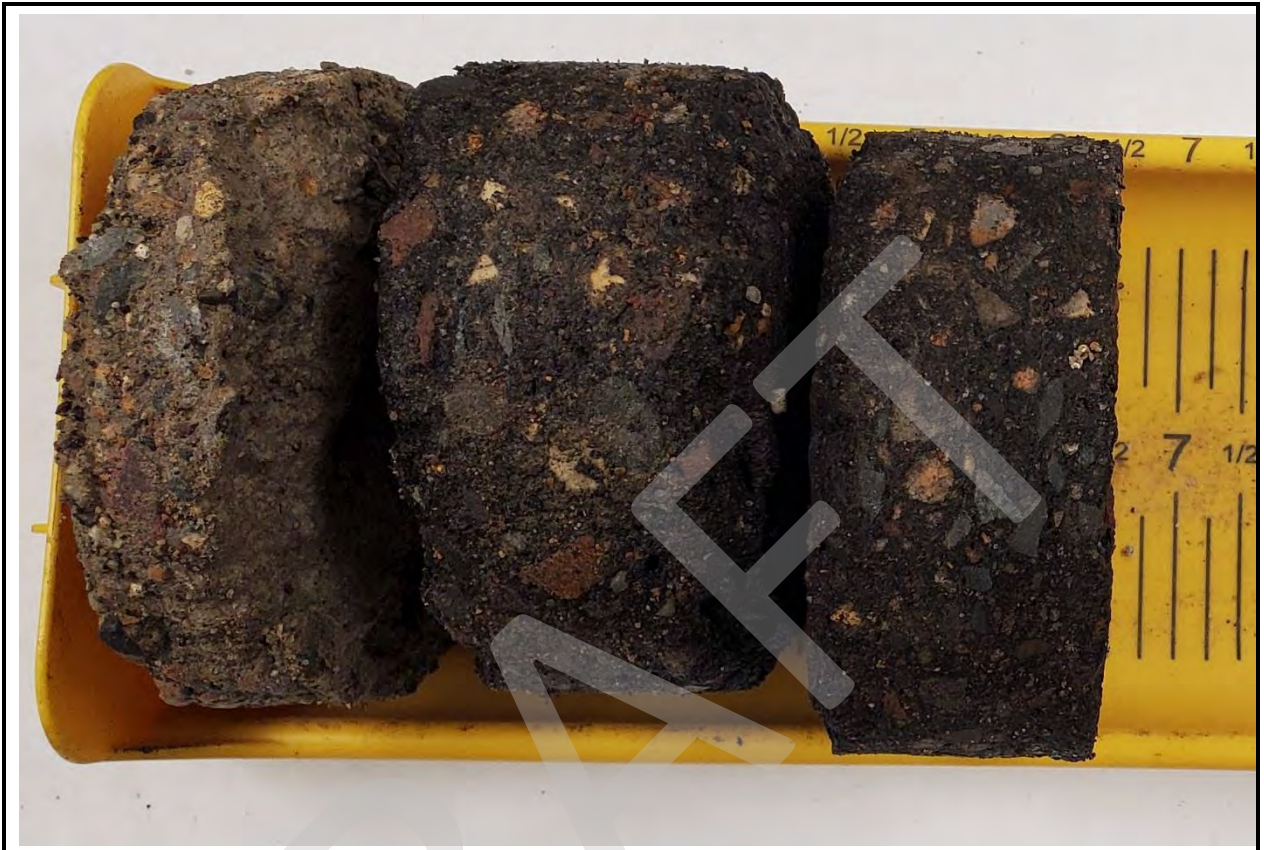
C-19

Core Photo Log

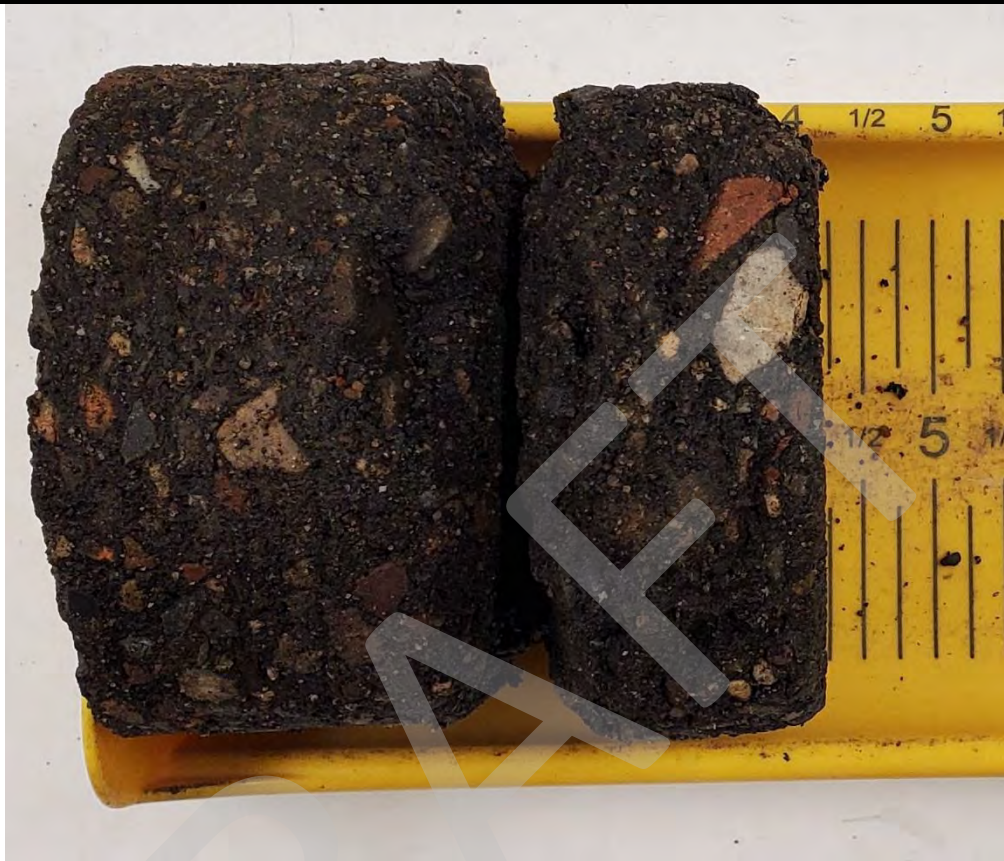
C-21

Core Photo Log

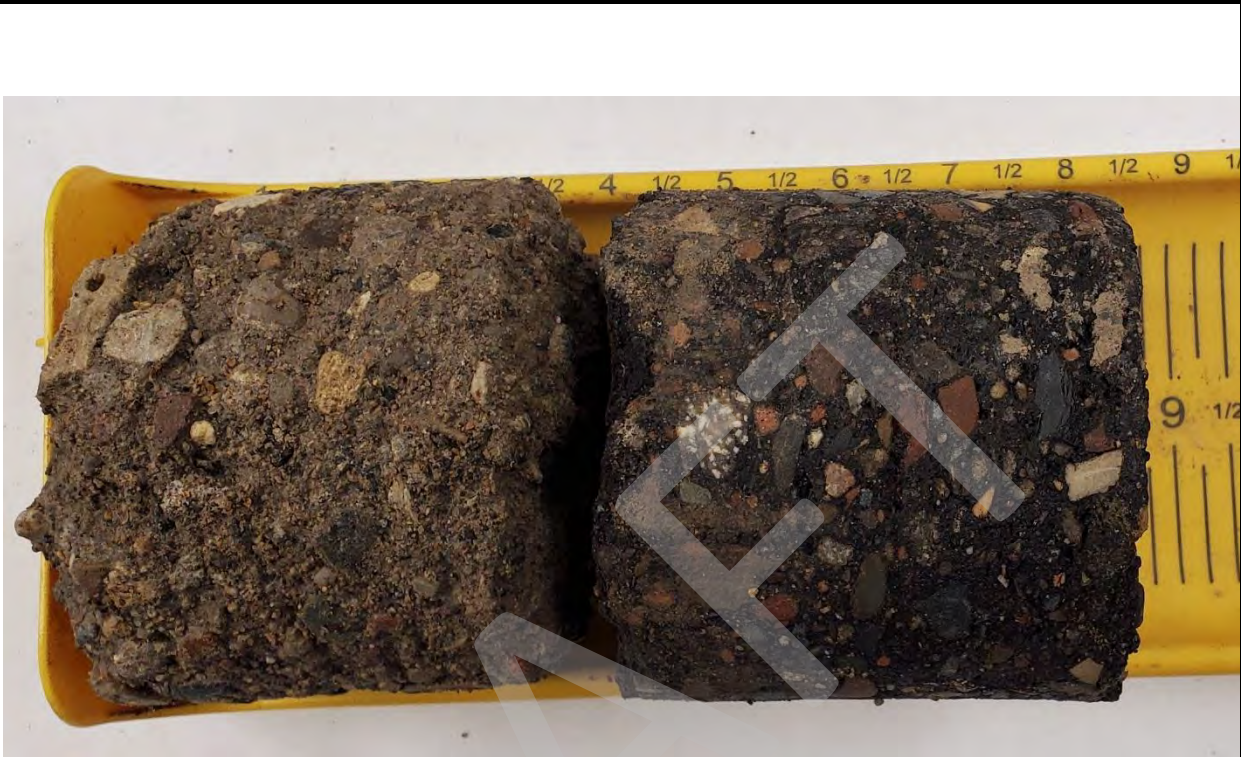
C-21A

Core Photo Log

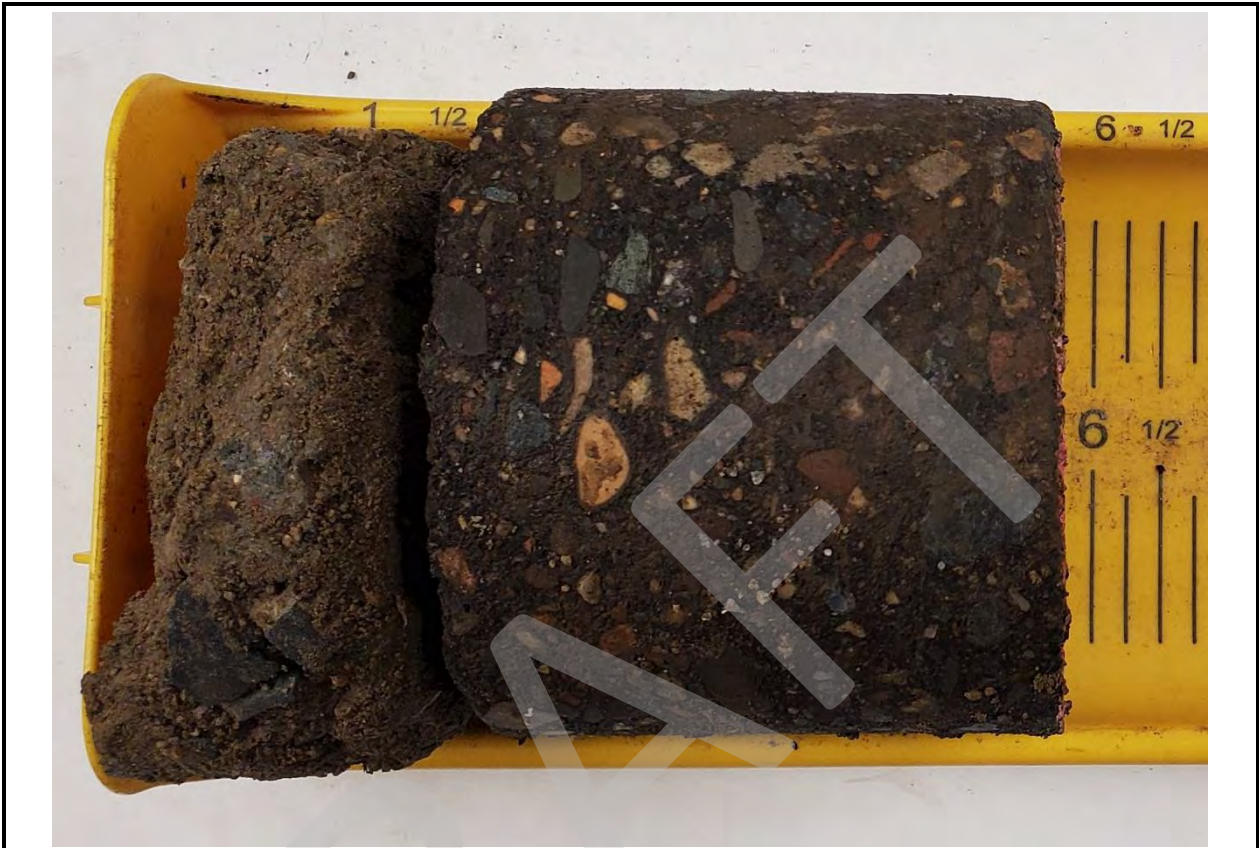
C-23

Core Photo Log
