FEASIBILITY REPORT

2025 STREET RECONSTRUCTION PROJECT

CITY PROJECT NO. 25-02

WSB PROJECT NO. 026423-000

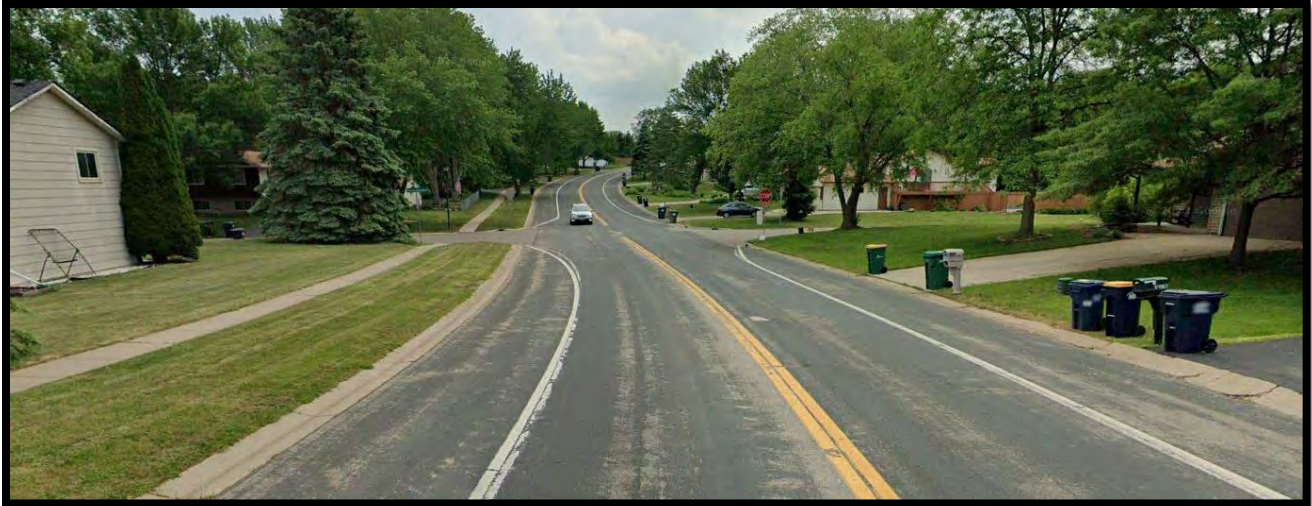
Photo 2. 170th Street West looking east towards Glenwood Avenue.

Hayes Avenue, 170th Street West, and Harbor Court are aging and experiencing differing severities of distress, including alligator, transverse, and longitudinal cracking. All streets within the project area are urbanized, with existing concrete curb and gutter. All of the curb and gutter is surmountable. The curb and gutter is in overall fair condition, with isolated instances of cracking, heaving, and settlements resulting in localized drainage issues.

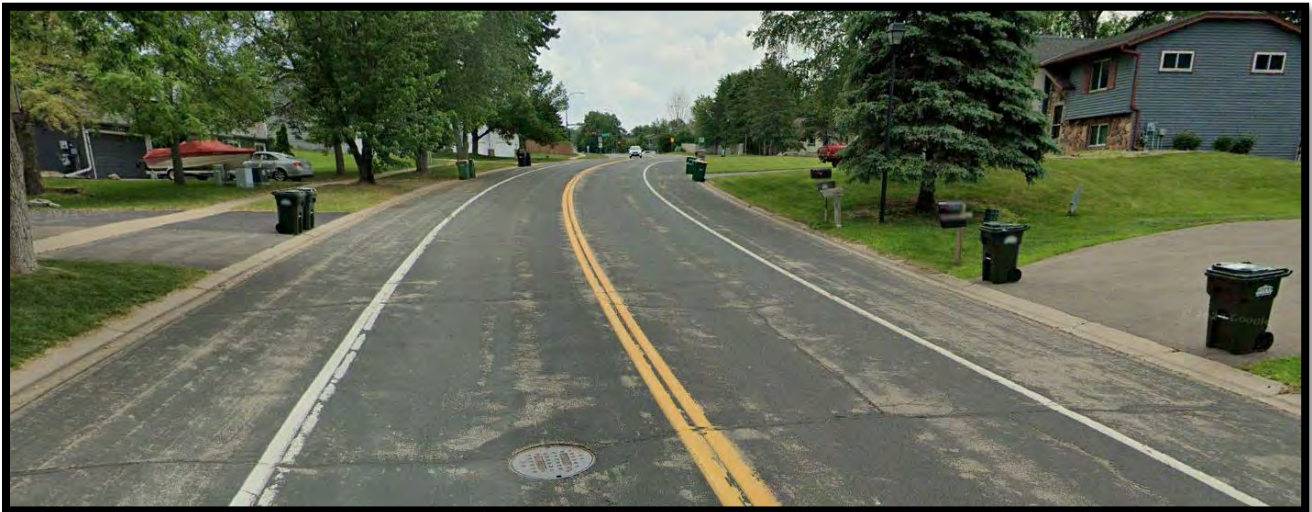
Photo 3. 170th Street West looking east towards Glencoe Avenue.

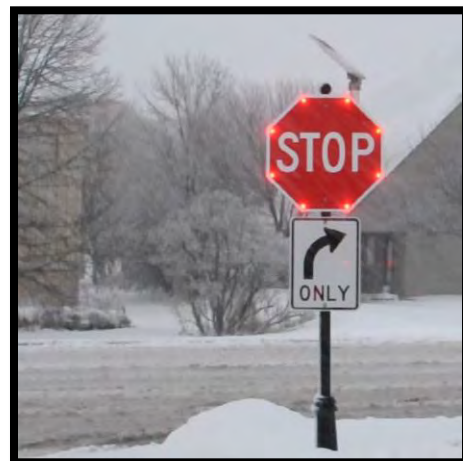
Changes to the existing traffic control signing can also have impacts on driver behavior. Stop signs with flashing lights around the sign perimter can draw drivers attention to the stop sign and encourage compliance. Other signing changes could include more and larger speed limit signs, including the installation of an orange placard at the top of the sign to draw attention to the signs. The installation of additional signs will result in some increases in installation and maintenance in the range of \$300 to \$500 per sign installed. Drawbacks to additional signing include complaints of “sign pollution”, as well as loss of compliance for the signs after installation as the signs become “part of the landscape” and drivers no longer observe the signs and compliance tends to decrease.

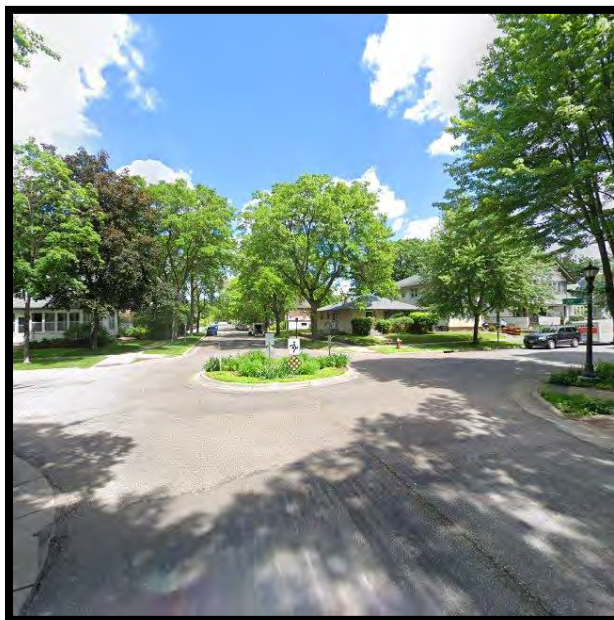
- Installation of traffic calming circles.

Traffic calming circles are typically small circles installed in the center of an intersection that do not require changes to the curb lines in the intersection, and are driven in a similar manner to roundabouts. Benefits of traffic circles may include slower vehicle speeds in the immediate vicinity of the intersection, but that reduction will likely diminish rapidly as vehicle distance from the traffic circle increase after exiting, and speeds may increase as drivers attempt to make up for their perception of lost time. Potential drawbacks to traffic

circles include increased construction costs, impacts on maintenance efforts, and speed reductions being limited to the immediate vicinity of the traffic circle.

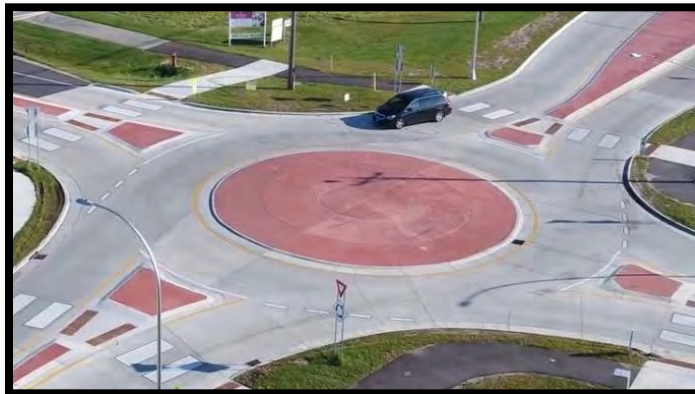
- Installation of mini roundabouts.

Roundabouts, including the mini roundabouts are highly effective in reducing the number and severity of crashes at intersections, and have localized impacts of reduced vehicle speeds. There are typically significant increases in construction costs with roundabouts that include right of way acquisitions, additional street lighting, and possible impacts to landscaping on private property.
